Middle East Nitrogen + Syngas 2019

REPAIR OF A HP SCRUBBER DAMAGED BY CORROSION

Stamicarbon Workshop
Middle East Nitrogen +
Syngas 2019

Alex Scheerder, Stamicarbon, The
Netherlands
October 2019

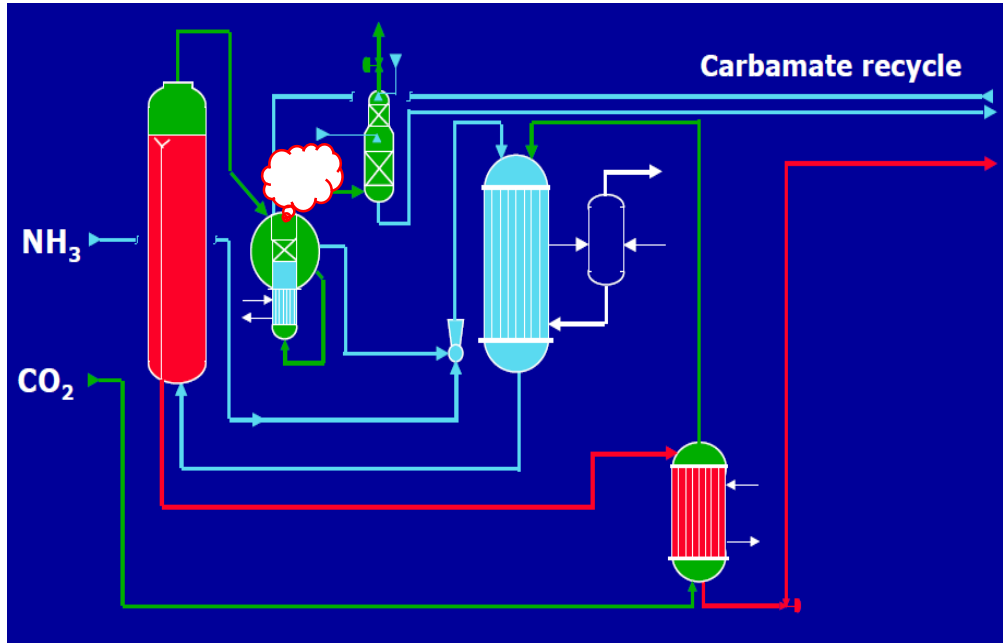
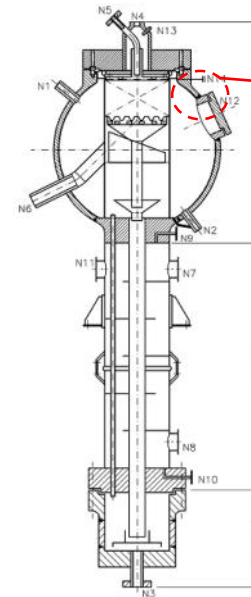
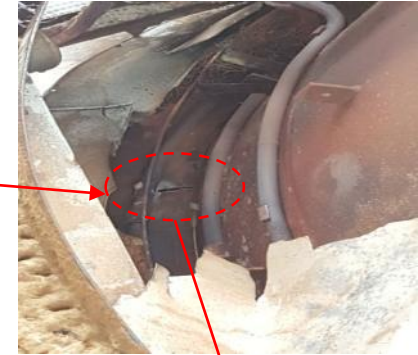
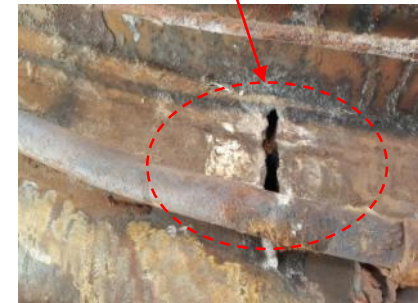
February 2018: leak to atmosphere observed in HP Scrubber sphere

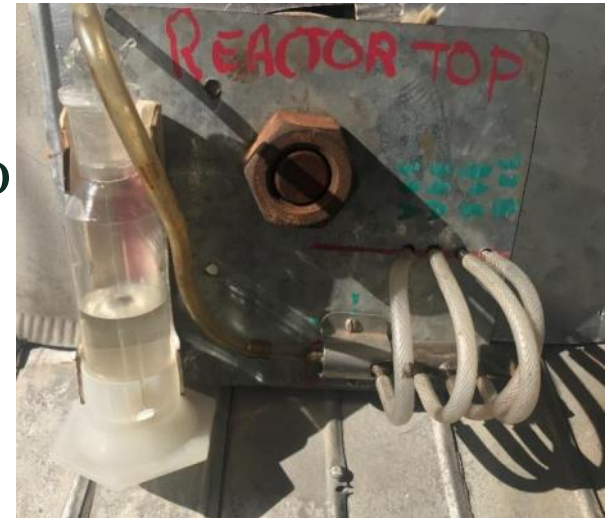
Present Leak detection system

1. Loss of containment
2. Corrosion of stainless steel barrier unnoticed by leak detection system
3. Unnoticed corrosion of pressure shell
4. 20MnMoNi45 carbon-steel: 53 mm
5. Near miss: Leak-Before-Break Scenario

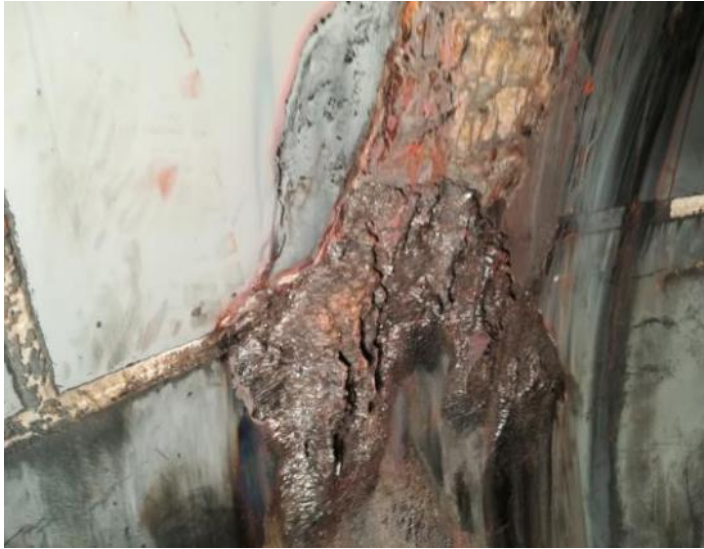
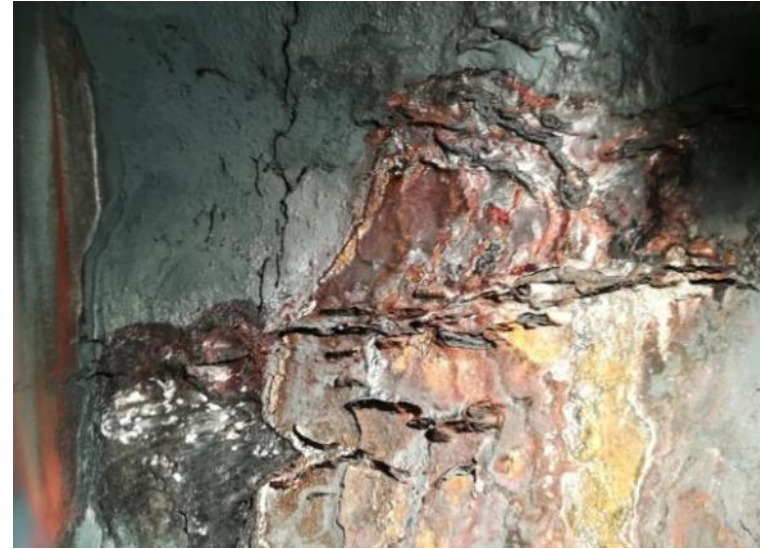
Severe corrosion of stainless steel liner: 316L UG nominal 9 mm thickness

- Strain Induced Intergranular Cracking
- Condensation of $\text{NH}_3/\text{CO}_2/\text{H}_2\text{O}$ gas
 - Hot off gas reactor
 - Insufficient insulation - tracing
- Plastic deformation of liner
 - Bending of plate
 - Temperature – pressure cycles
 - Poor fit
 - Large grain size (ASTM 2.5-3)
- Contaminants such as Sulphur
- Slowly propagating cracks

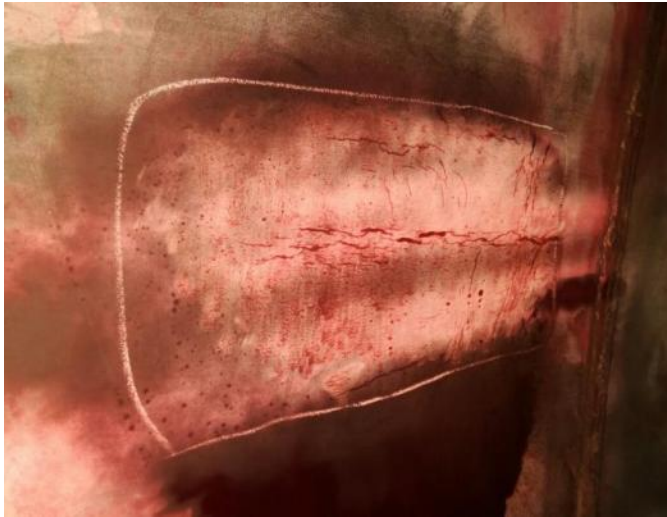
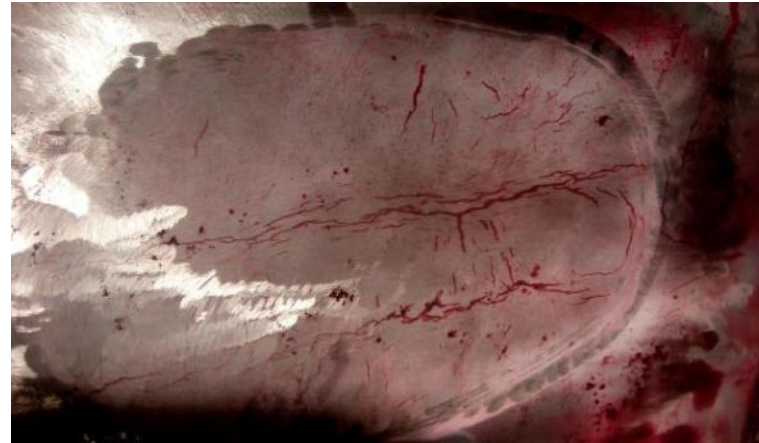
- Liner severely cracked
- Many cracks through wall
- Ammonium-carbamate leaking behind liner

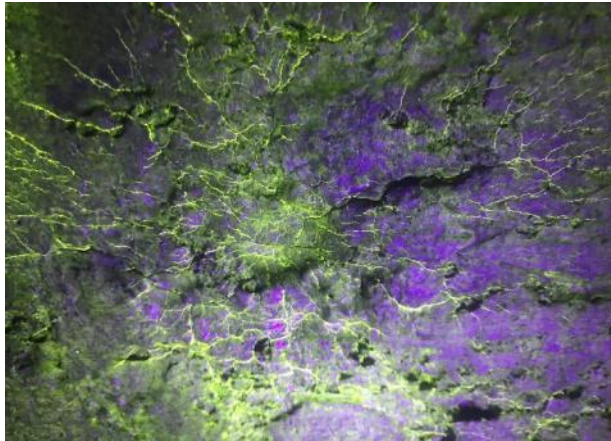
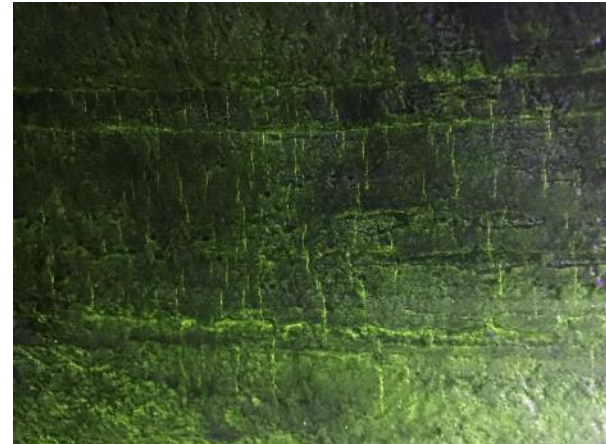
- Carbon-steel pressure shell
- Severely corroded by ammonium-carbamate
- Local wall thinning and Stress corrosion cracks

- Wall thinning carbamate corrosion
- Hydrogen Induced Stress Corrosion Cracking (HISCC)
- Hydrogen developed by cathodic corrosion reaction
- Steel metallurgy (too high Carbon Equivalence)
- Sulphur enhances hydrogen uptake
- Slowly propagation of cracks

- ❖ Care taken to outgas hydrogen (soaking)
 - Before welding
 - After welding
 - Take care to minimize welding as much as possible
- ❖ Remove all cracks by careful grinding
- ❖ Determine minimum required wall thickness (Fitness For Service assessment)
Minimum required wall thickness: 37 – 45 mm
- ❖ Repair welding until meeting minimum required thickness
- ❖ Subsequent filling with metal epoxy compound
