CASE STUDY

CATASTROPHIC FAILURE OF A UREA REACTOR

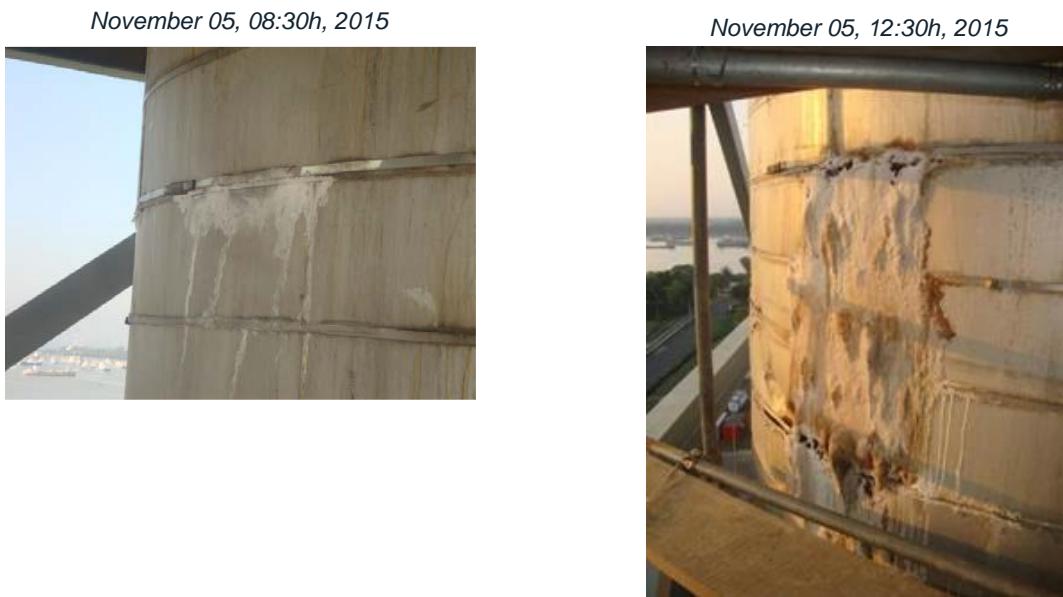
During a routine inspection at 08:30, the plant operator noticed crystallized white product accumulating on the insulation sheeting of the urea reactor, as shown in Figure 1. This buildup worsened rapidly over time, and the operator also detected the presence of ammonia vapor.

Figure 1: Crystallized product visible on cover sheeting insulation urea reactor

Initially, it was suspected that the leak originated from the man-way cover, as the leak detection system showed no signs of a breach. However, upon closer examination, evidence suggested a potential leak in the liner, prompting the plant to be shut down for a thorough inspection.

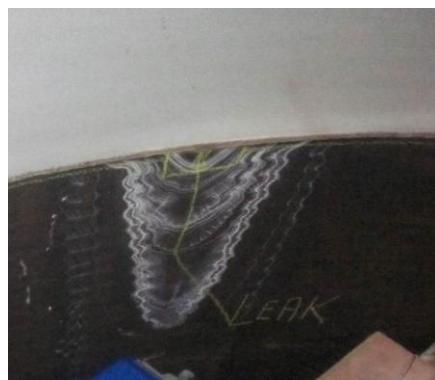
The leak detection pipes linked to the suspected section of the urea reactor were detached, revealing the presence of ammonia in the leak detection hole. Upon opening the reactor, the source of the leak became readily apparent. It was traced to the circumferential weld joining the original 316L UG liner (the brown surface in the lower part of Figure 3) with the X2CrNiMo25-22-2 liner (the grey upper part in Figure 3), which had been added in 2002. The relining of the reactor's top section had been required due to earlier corrosion issues.

Figure 3: Leak found in the circumferential weld between the X2CrNiMo25-22-2 relined part (top) and original 316LUG liner

The pinhole leak in the liner created severe corrosion attack of the c-steel pressure shell and the reactor was put out of service just in time. The state-of-the-art leak detection however failed to indicate the leak; this was due to a combination of wrong commissioning of the system and failure of some components; thus, insufficient inspection and maintenance of the system.

It was decided to make a temporarily repair and to execute a full repair later, which was executed successfully within 1 year. The integrity of the reactor is restored again.

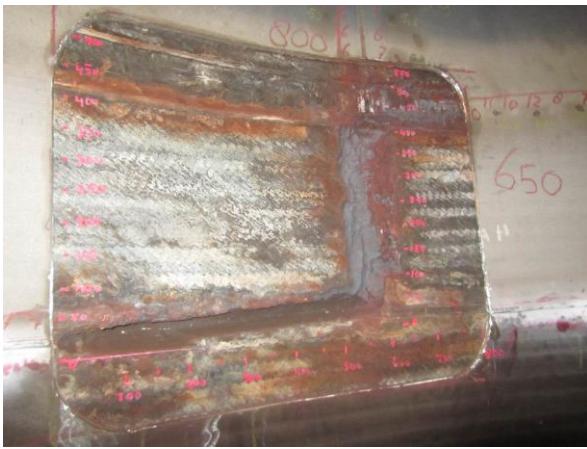
To access the integrity of the c-steel pressure shell a window was cut from the liner around the leak point, see figure 4. Corrosion of the c-steel vessel wall was evident. Wall loss ranged between 10 and 30 mm. In one local area (80 x 50 mm) a maximum wall loss of 58 mm was found (remaining thickness 50 mm; original 112 mm), see figure 5.

Figure 4: Corrosion of the c-steel pressure shell visible

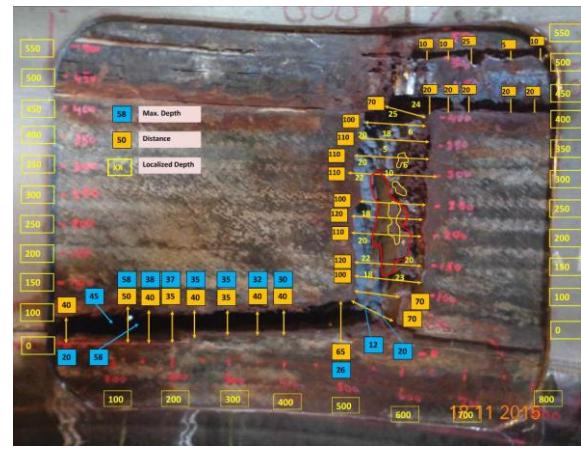
Figure 5: Maximum corrosion depth: 58 mm
