CASE STUDY

CATASTROPHIC FAILURE OF A HIGH- PRESSURE SCRUBBER

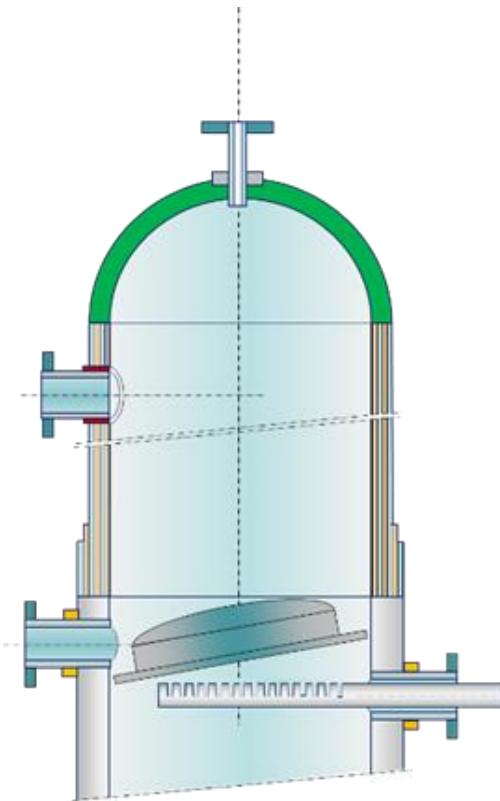
The function of the HP Scrubber is to remove inerts from the process gas. The ammonia and carbon dioxide are condensed and reused in the synthesis loop. The inerts are vented to the atmosphere. In the dome part of the HP Scrubber the presence of an explosive mixture of H₂, NH₃ and air is possible. Therefore, the dome part is designed such to avoid any loss of containment in case of an explosion.

Figure 1: HP Scrubber with cylindrical dome in multi-layer design. Rupture disk closes the dome area at the bottom

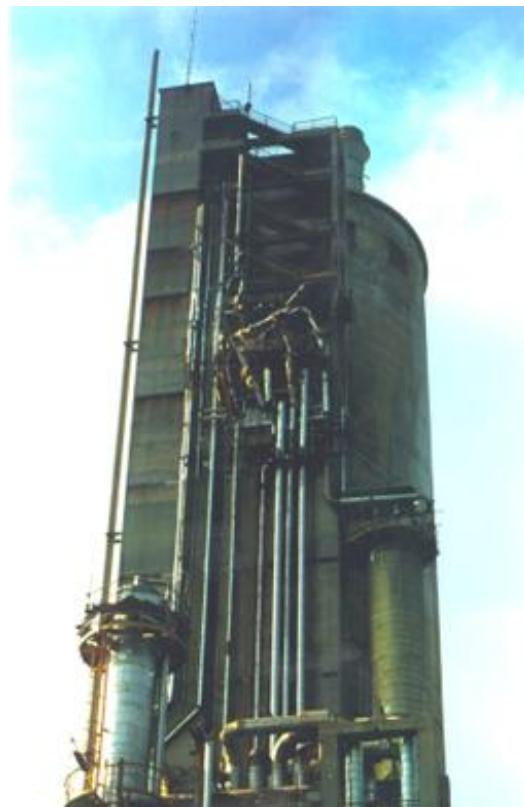
Two days after a normal maintenance shutdown, the high-pressure Scrubber ruptured at 04.30 hr. in the morning. The HP Scrubber, designed with a cylindrical dome (see figure 1) is located high up in the urea plant, see figure 2. The plant was running normal and fortunately nobody was present in the plant at the time of the rupture.

Figure 2: Location of HP Scrubber

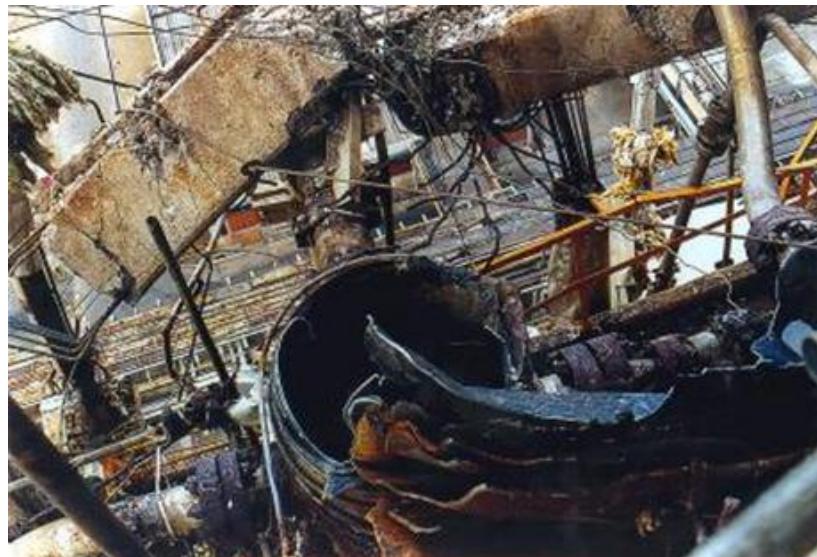
The top part of the HP Scrubber was ruptured and completely disconnected from the vessel. One part of the rupture disk was found back outside the urea plant site. Also surrounding equipment, piping and concrete structure were damaged, see figure 3.

Figure 3: Damaged top part of HP Scrubber and

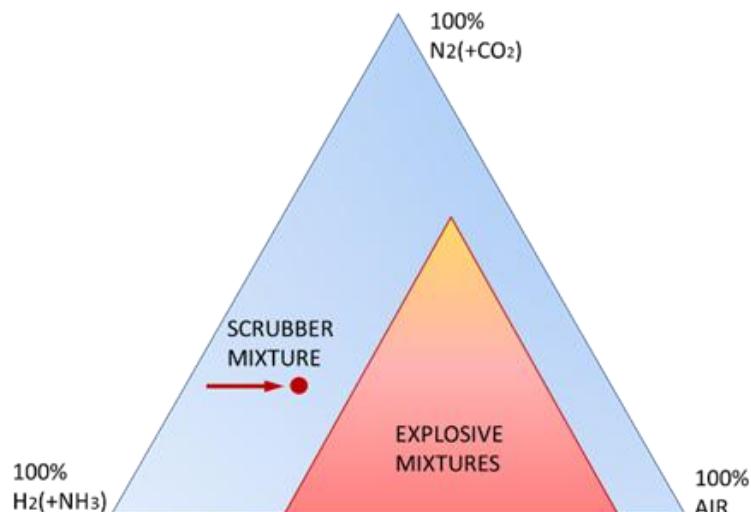
The gas composition present in the HP Scrubber just before the rupture was analyzed and the mixture was not within the explosive range as is presented in figure 4.

Figure 4: Gas composition in HP Scrubber just before the rupture; in the safe range

- Prior to the rupture the operating point is outside the explosion triangle
- The process condition was stable and normal
- No other plant disturbances occurred

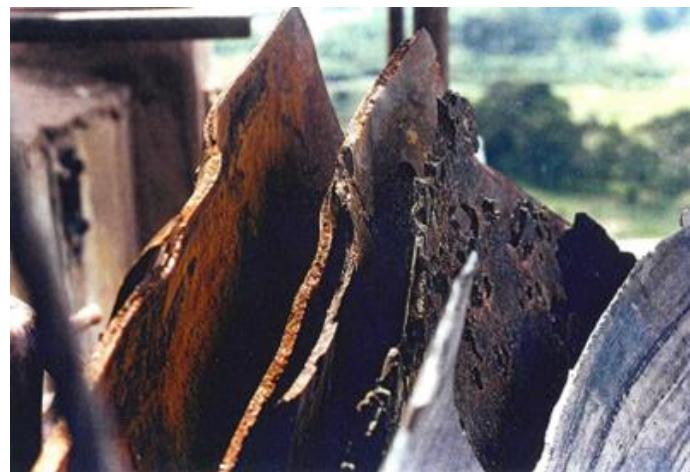
The cylinder part was ruptured in longitudinal direction; the three inner c-steel layers were through wall corroded, see figure 5, whereas the outer (fourth layer) was only minor attacked.

Figure 5: Severe corrosion of three inner c-steel layers

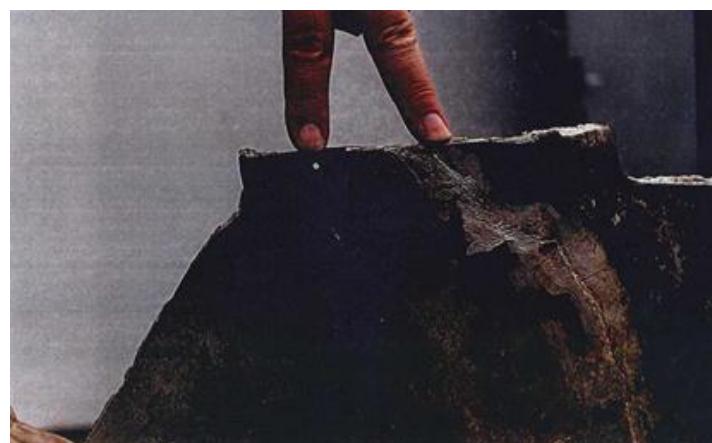
Figure 6: Backside of liner plate with carbamate corrosion

The corrosion is due to ammonium-carbamate leaking through the leak in the liner. Carbamate corrosion is visible at the backside of the liner, see figure 6. A cover plate was welded onto the liner at the location of the leak. The leak path was developed along a weld defect in the fillet weld of the cover plate, see figure 7.

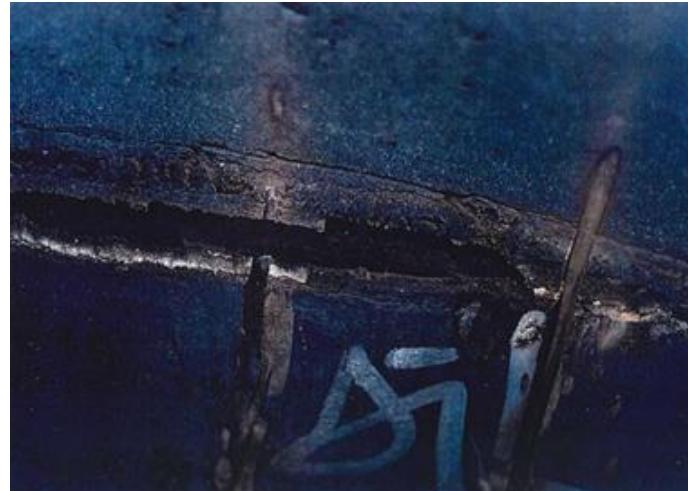
Figure 7: Leak path via fillet weld of cover plate and leak detection hole towards the multi-layered pressure shell.

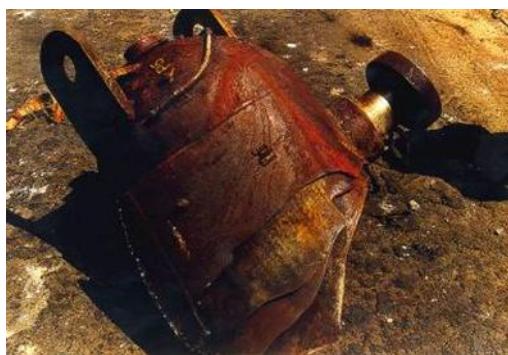
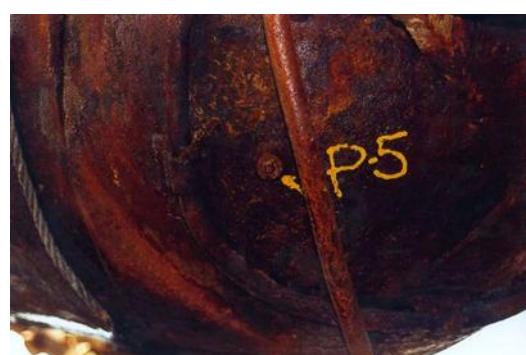
The HP Scrubber was equipped with a leak detection system. During transport from the manufacturer shop to the plant site the leak detection holes are plugged to avoid ingress of debris and moisture. However, during the commissioning of the HP Scrubber one of the leak detection hole was not opened and connected to the system, see figure 8. Therefore, the leak in the cover plate was unnoticed and corrosion of the pressure shell could commence.

Figure 8: hemi-head part of dome with plugged LDS hole
