RECONNECT
SYMPOSIUM 2022

Importance of proper BFW quality in Pool Condenser plants

Conference name Stamicarbon Symposium 2022 – Reconnect
Conference date 16th – 19th May 2022
Author(s) Alex Scheerder and Bart Gevers
Classification Public

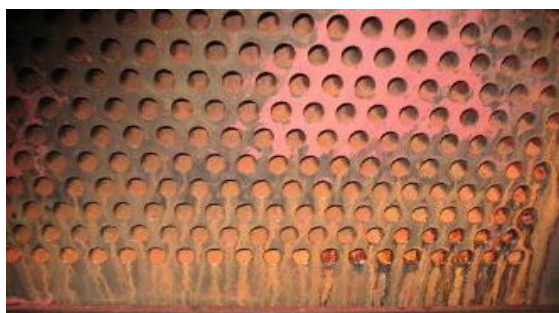
Due to a sudden increase in the conductivity of the steam condensate circulating through the U-bundle of the Pool Condenser, a leak was suspected and the urea plant was shut down for inspection. Upon opening the Pool Condenser at the LP steam side, the holes in the tube sheet were visibly enlarged up to Ø 22 mm, see figure 3.

Figure 3: Carbon steel tube sheet from LP tube side;

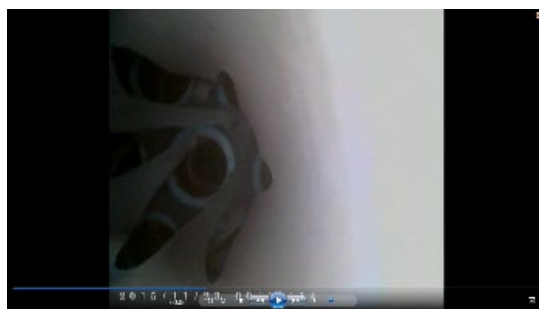
A video endoscope inspection revealed cavities in the carbon steel part of the tube sheet, just underneath the weld overlay at the upper outlet side, see figure 4. Almost all holes at the outlet side were affected. The holes at the condensate inlet side (lower part of the tube sheet) were not affected at all.

Figure 4: Cavity inside the holes near the tube sheet holes enlarge weld overlay

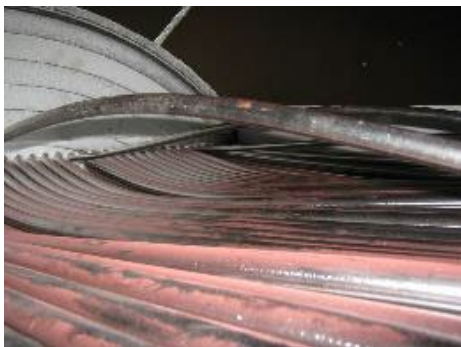
Inspection of the shell side of the Pool Condenser further revealed severe bending of the tube bundle, as well as inward bulging of the weld overlay in the top part of the tube sheet, see figure 5.

Figure 5: Bent U-bundle and stay rods

At the bottom part of the U-bundle no bending was observed, however the upper part of the baffle plates were bent towards the tube sheet.

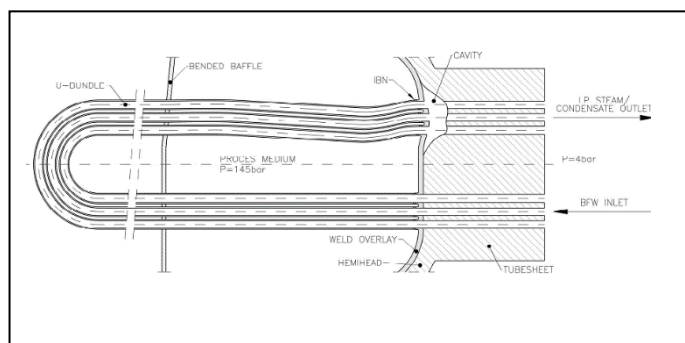
Figure 6: Schematically presentation of the cavity in the tube sheet

These observations suggested that a large cavity was formed in the top half of the tube sheet (2-phase steam/steam condensate outlet) as is schematically presented in figure 6.

Due to the difference in pressure between the synthesis ($P=145$ bar) on the shell side and the pressure in the cavity ($P=4$ bar) the overlay weld is pressed into the cavity. This leads to a (torsion) stress on the tube bundle and the tube bundle/weld overlay connections. As a result of this stress apparently a leak was formed, either in the weld overlay or in one of the U-tubes or internal bore welds. This necessitated the plant owner to shut down the plant.

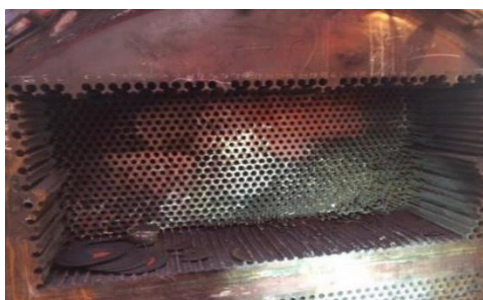
Figure 7: Cavity in tube sheet

A repair was only feasible in case the integrity of the bent weld overlay and the twisted IBW connections were still acceptable. Therefore, the first step was to check the integrity of the weld overlay and the IBW connections in the top part of the tube sheet. For this reason it was decided to remove completely the remaining carbon steel in this area, to have full access to the weld overlay. After removing more than 400 mm of carbon steel, the weld overlay became assessable (see figure 7 and 8). Inspection showed that the condition of the weld overlay was still sufficient for a repair of the tube sheet. The repair procedure and execution of the repair was done in cooperation with SBN Austria, the original equipment manufacturer (OEM) of the Pool Condenser. The leak spot was identified in the weld overlay and repaired by welding and in general the weld overlay suffered only from shallow radial cracks, which were grinded out without weld repair.

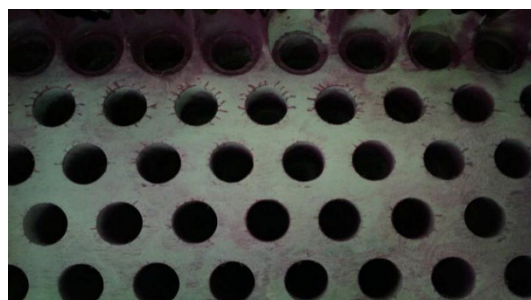
Figure 8: Cracks in weld overlay

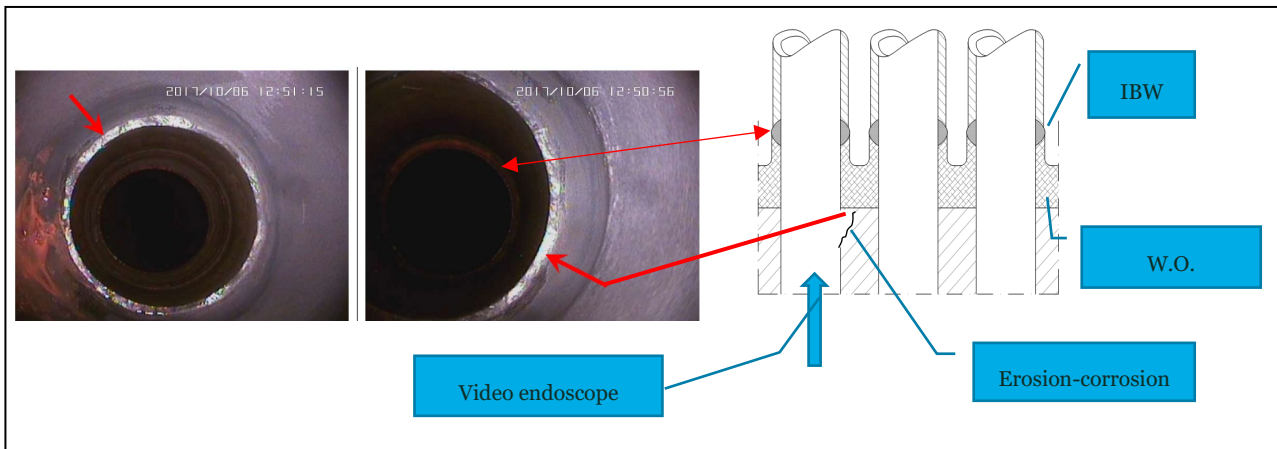
It is advised to check the tube sheet at the LP steam side for erosion-corrosion damages on a regular basis during planned turn arounds. The inspection program entails a video endoscopic inspection of the holes in the top (vapor exit side) half of the tube sheet. Figure 14 shows an example of small erosion-corrosion damage just behind the weld overlay.

Figure 14: Video endoscope image of a hole in tube sheet, showing small erosion-corrosion damages (increase hole size) of carbon steel just behind the stainless steel weld overlay

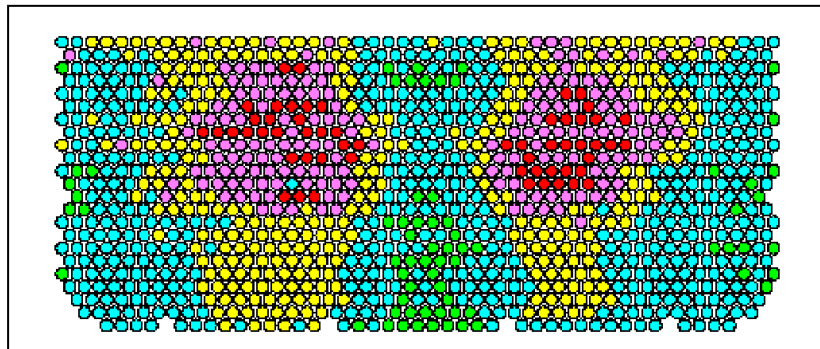
When erosion-corrosion damage is observed, it is advised to measure the extent of the damages in each tube. The increase in hole size can be measured by eddy-current method and the hole size can be plotted in a tube sheet lay-out, see figure 15.

Figure 15: Measurement of hole size in an affected tube sheet due to erosion-corrosion. Non affected holes are colored green, affected holes are colored blue, yellow, purple and red (in order of increasing hole size)

In case erosion-corrosion is detected a strength calculation is advised, to check if the damaged tube sheet still meets the design rules. If this is not the case, a so-called Fitness For Purpose (FFP) assessment is advised, using Finite Element Analysis (FEM calculations). Based on the tube sheet strength assessment, further mitigation actions and/or a repair plan needs to be defined.

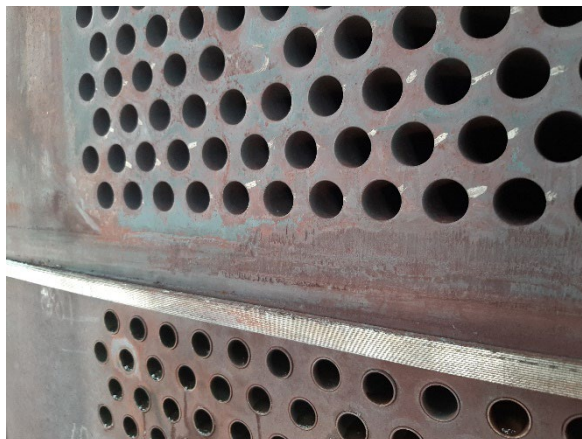
This repair strategy is already executed in two Pool Condensers and several other repairs are planned. To date both of these sleeved Pool Condensers have been inspected and the sleeves perform well and still in place, see figure 18.

Figure 18: Condition of the sleeves installed in the bottom part of the tubesheet after two years on-stream time.
