Importance of proper boiler feed water quality in Pool Condenser / Reactor plants

Alex Scheerder

18 May 2022

Introduction and background

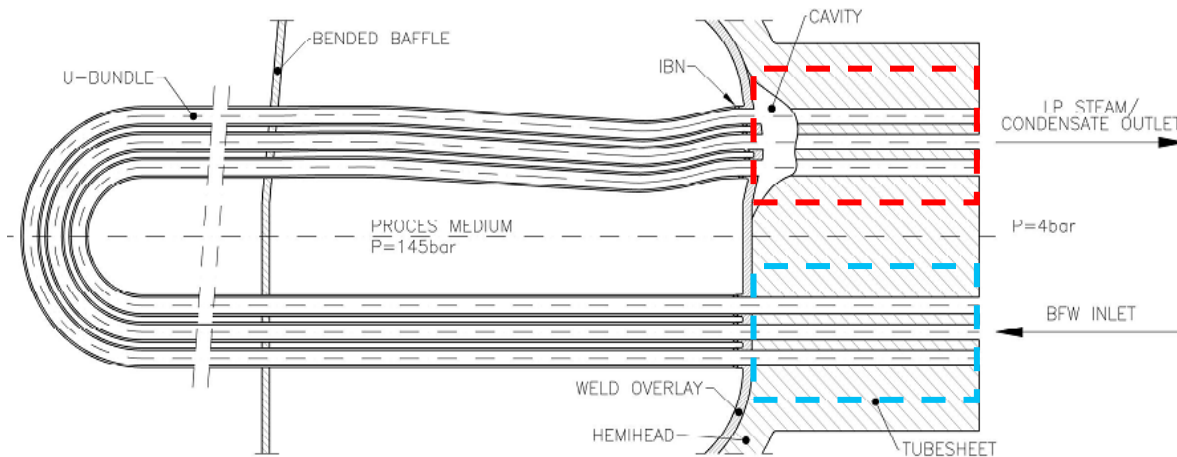
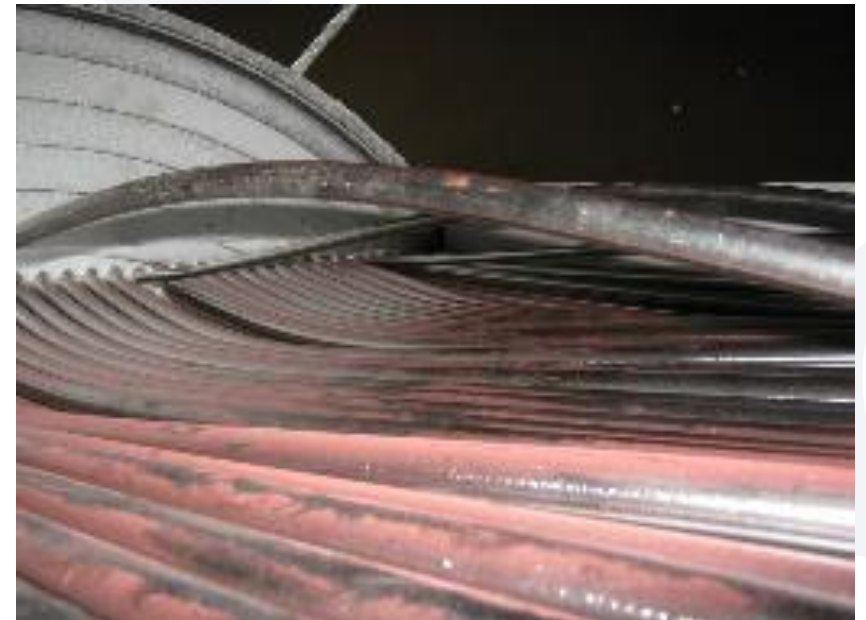
- Cavity in carbon-steel tube-sheet at steam condensate outlet
- No damages at BFW inlet side
- Severely bended U-bundle at process side, but no corrosion issues

- Cavity in carbon-steel tube-sheet due to Flow Accelerated Corrosion (FAC)
 - Protective Hematite/magnetite layer dissolved by corrosion
 - Wall losses due to abrasive action of flow of steam-condensate (droplets)
- Depending on temperatures: high FAC at 150 °C
- Depending on too low pH and absence of oxygen

- Cavity complete excavated to repair bended weld-overlay
- Cavity closed with steel plates having pre-drilled holes
- Installation of sleeves in holes
- Temporarily repair; Pool Condenser replaced within 2 years

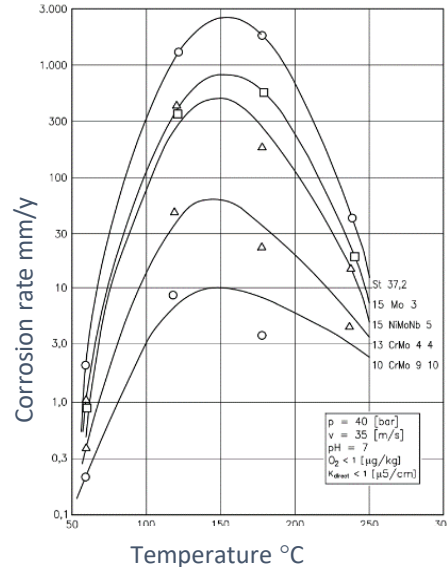
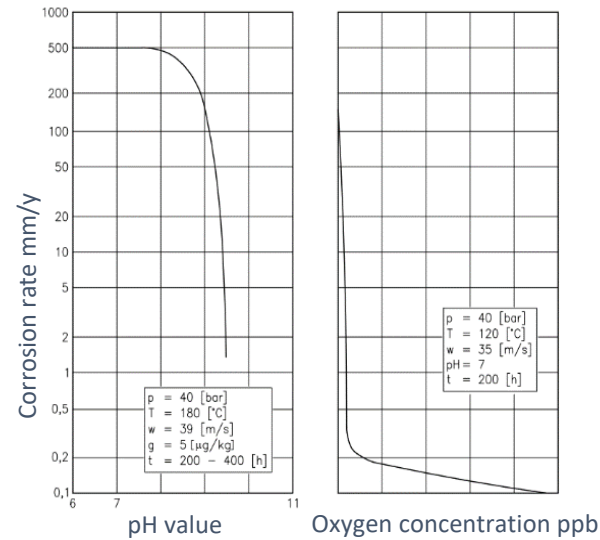
pH > 9.5

Oxygen approx. 10 ppb
