HPCC Tubesheet repair after conductivity increase in the steam condensate due to the leakage

Workshop 14th Stamicarbon symposium

Cagri Ozturk 19 May 2022 Jaarbeurs, Utrecht

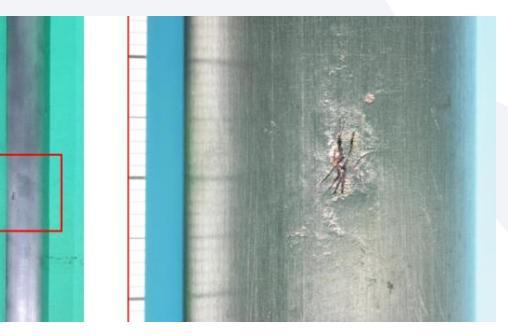
A leaking plug

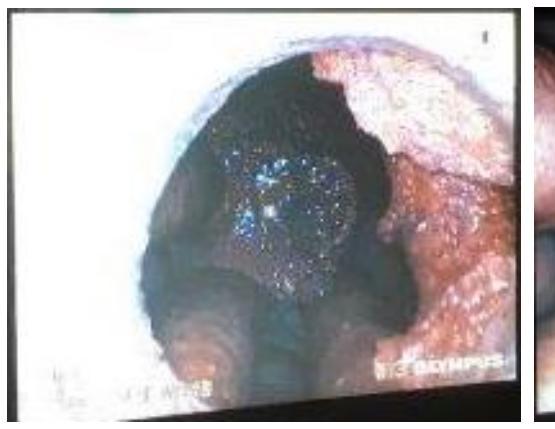
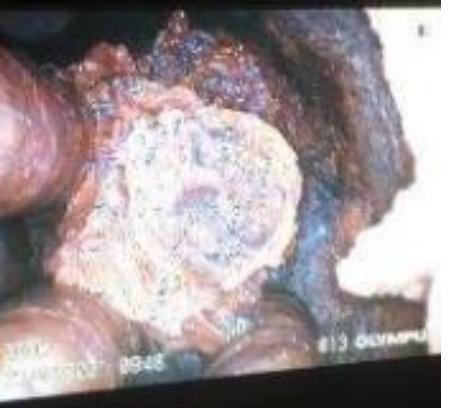
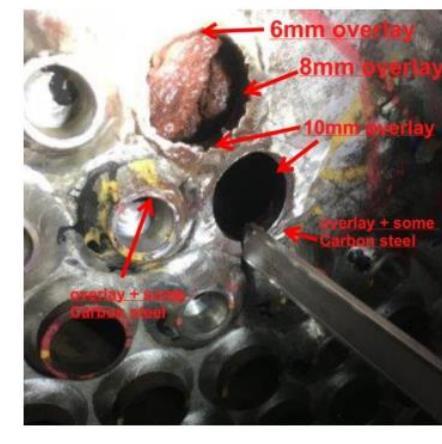
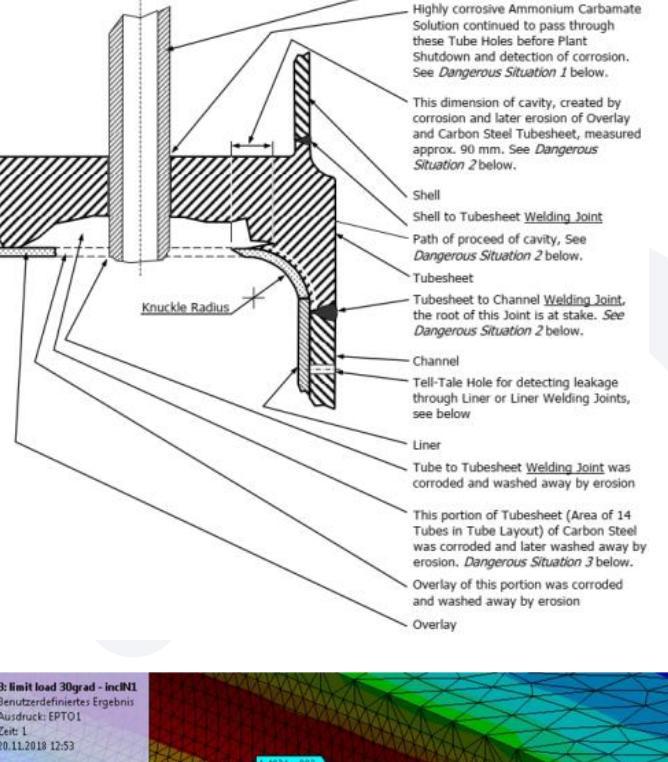
- Leakage of carbamate can cause to corrosion of tubesheet resulting in a cavity or metal loss
- In one case, a plugged tube was leaking, carbamate went into just above the weld overlay.
- the C-steel tubesheet is corroded also partially the weld overlay and the surrounding HEX tubes at the back side
- Cavities on the knuckle radius of the tubesheet are subject to higher stress levels during operations
- The corrosion of the carbon steel tubesheet can lead to unsupported area underneath the weld overlay which needs to be supported (Leading to higher bending moment on weld overlay without the carbon steel support)
- Cavities needs to be closed to restore integrity of the tubesheet for further safe operations.
- · Stamicarbon can support on the repair procedure

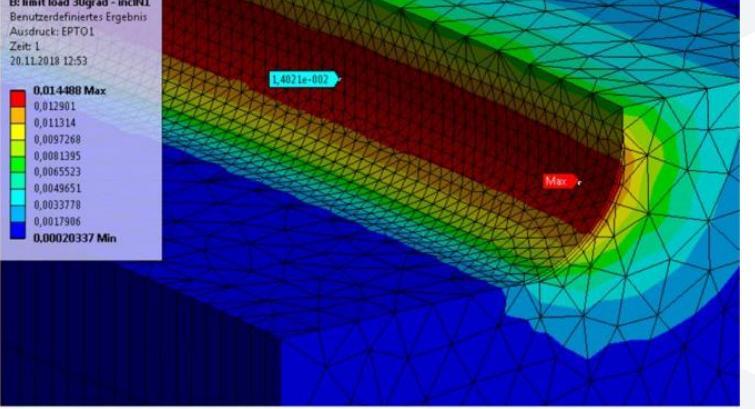
Local high stresses in the knuckle radius between tubesheet and HP Channel.
