# HP PIPING INSPECTION

Alex Scheerder

27 October 2019, Muscat Oman

**Process lines in the HP synthesis  
section of a Urea Plant**

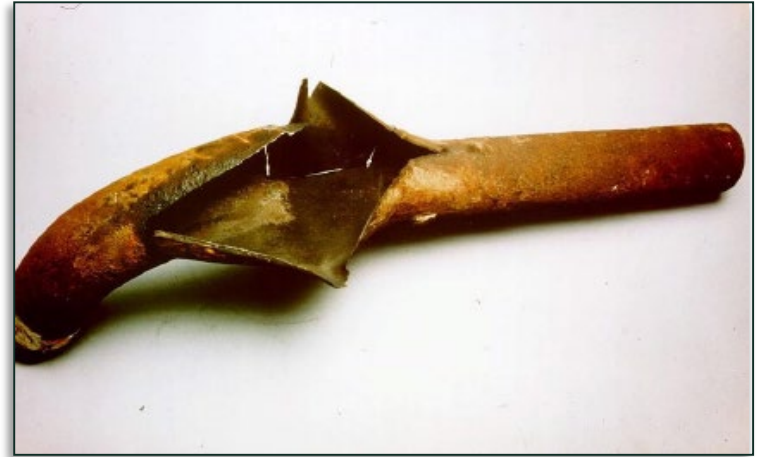
**Ruptured high pressure C-steel pipe (CO<sub>2</sub> supply line) as a result of atmospheric crater type attack**

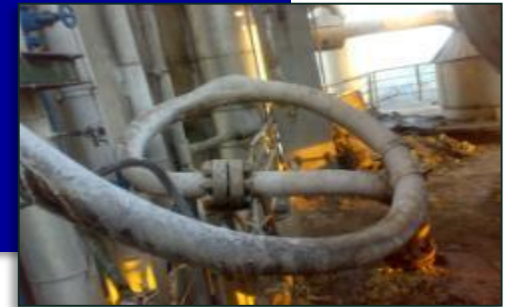
## Ruptured HP gas line

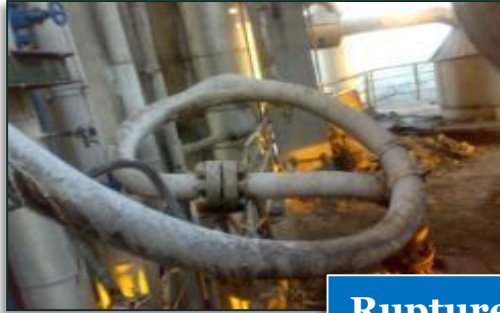
**Ruptured pipe**

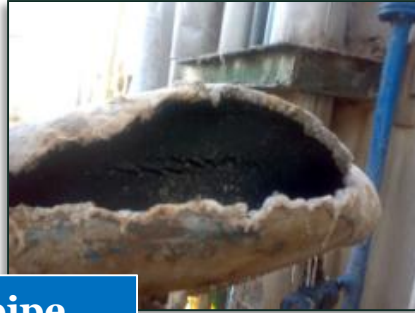
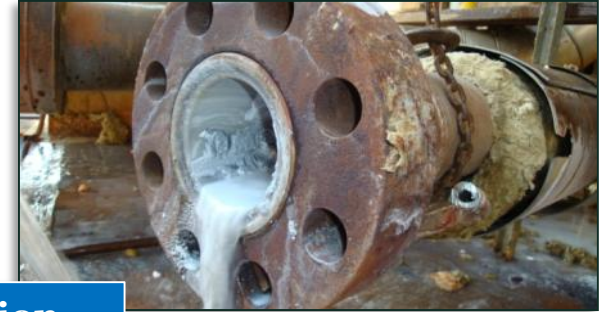
**contamination**

Stress Corrosion Cracks at process side

- Upset conditions
- Chloride contamination not recognized
- HP Equipment were cleaned, inspected
- HP pipin were cleaned, but not inspected

**Incorporate upset conditions in RBI program**

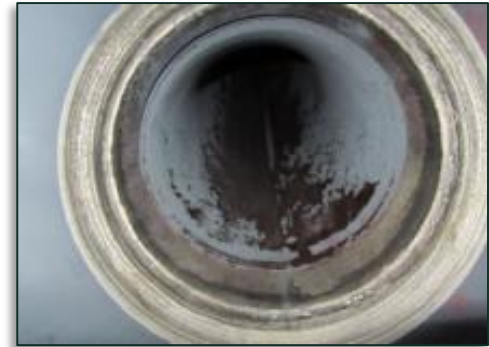
Condensation corrosion in HP gas line due to insufficient insulation

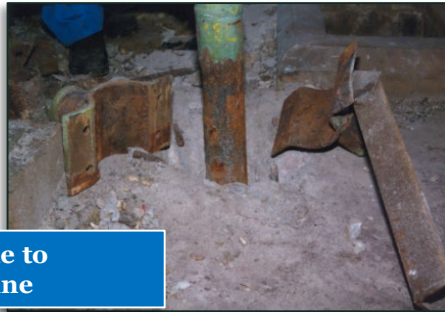
Severe corrosion under clamp due to damaged coating in C-steel NH<sub>3</sub> line

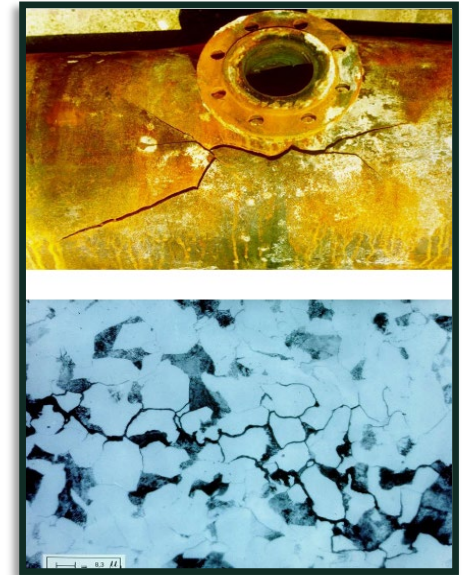
Stress Corrosion Cracking (SCC) due to nitrates in C-steel 3 bar steam pipeline near nozzle

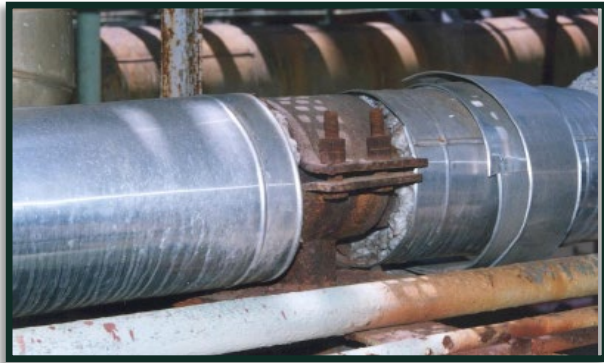
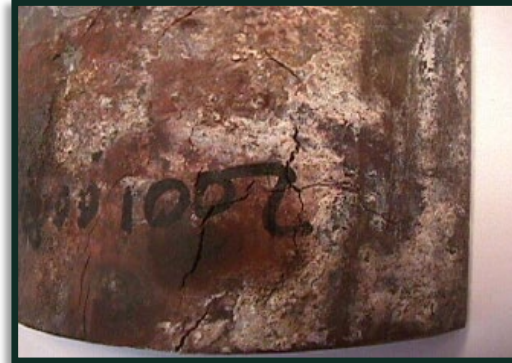
**C-steel clamp allowing ingress of water and serious chloride SCC in AISI 304L pipeline underneath the clamp**

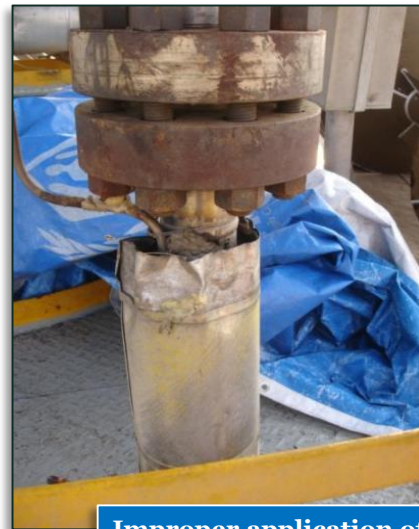
Improper application of insulation sheeting

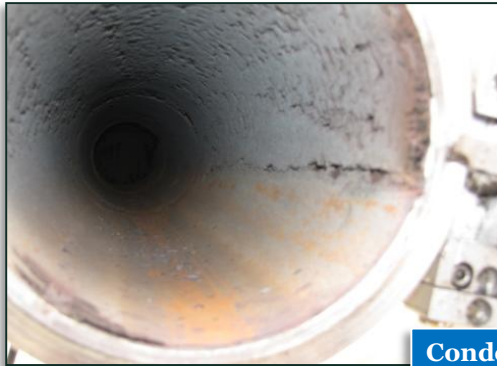
Condensation corrosion in a HP gas line in urea plant

- Dosing of oxygen for passivation of austenitic SS pipes
- Application of insulation, steam tracing to combat condensation corrosion
- Selection of proper construction materials, i.e. SAFUREX
- Avoid dead pockets / stagnant conditions
- Avoid contaminations of Chloride / Sulphide

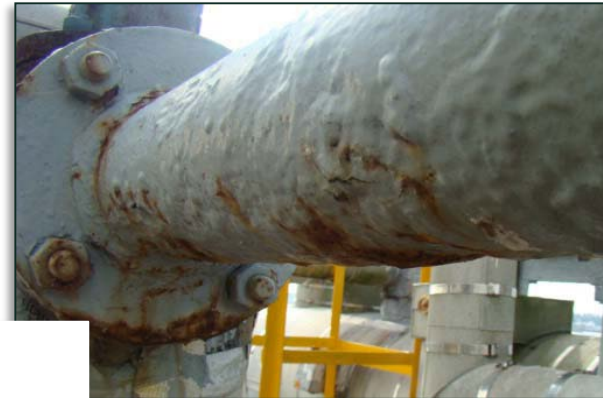
**Incorrect application of a coating system on a carbon steel  $\text{NH}_3$  pipeline in urea plant**

- Appropriate and correct application of coating systems
- Appropriate insulation materials (no Chloride)
- Correct installation of tracing
- Correct application of water tight insulation covers
- Immediately repair dammaged or wrongly installed insulation

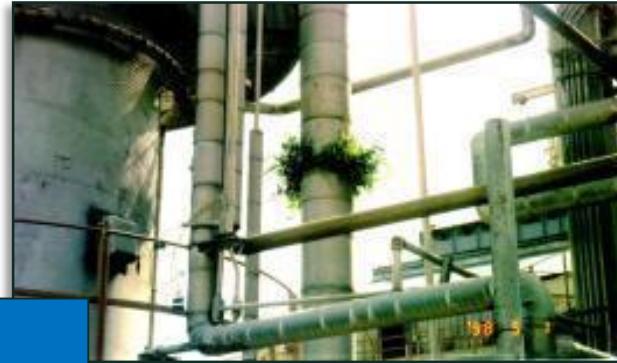
Awareness to take timely actions to lower risk for atmospheric corrosion (example in urea plant)
