How to Manage Leaks in Urea Plants

Jo Eijkenboom
Mark Brouwer
UreaKnowHow.com

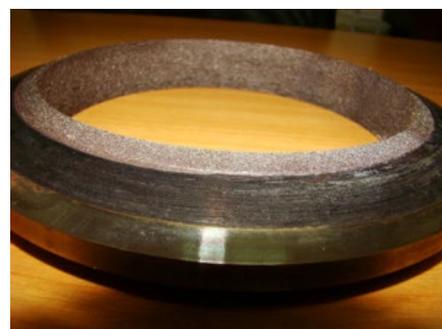
Figure 3 and 4: Line sealing principle of a lens ring (left) and a real life example showing normal passive corrosion on the process side of the lens ring (right)

The shape of the lens ring is such that a line-shape sealing ring is created as indicated in Figures 3 and 4 below.

The big advantage of a line-shape sealing ring is that less force is required to create the sealing. The sealing effect is achieved by elastic deformation of the surfaces and that implies that applying

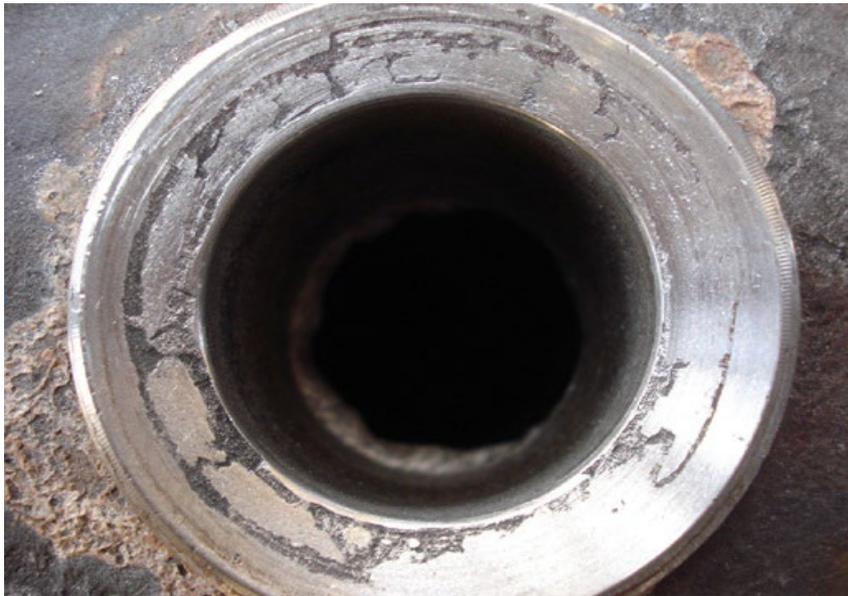
Figure 5: Signs of crevice corrosion of a stainless steel flange face

It is common knowledge that crevices should be avoided in the high-pressure synthesis sections of urea plants. In a crevice ammonium carbamate liquid enters, oxygen will be depleted and corrosion rates (active corrosion) increase leading to crevice corrosion and the flange connection will start to leak. The picture below shows the result of crevice corrosion on a stainless steel flange face.

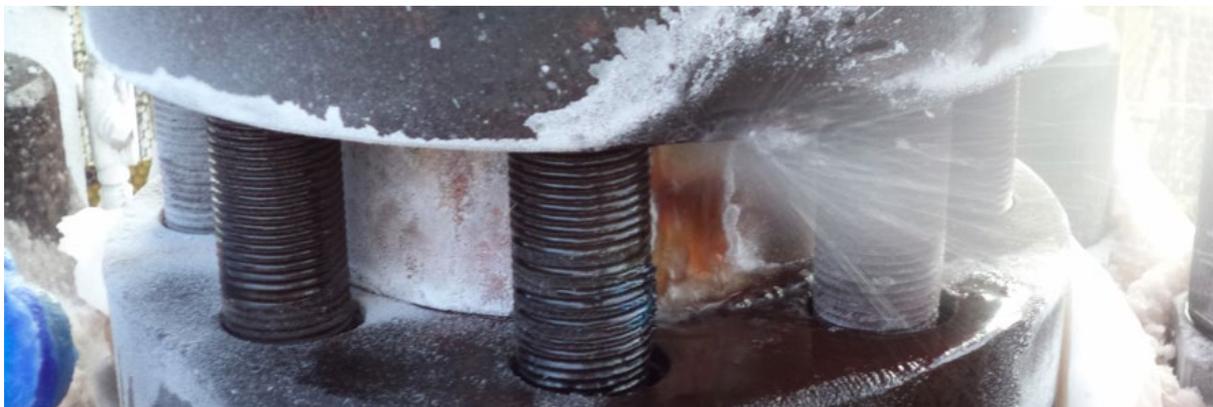
Figure 6: A typical leak of a lens ring flange connection

However a crevice and/or a leak can occur in a lens ring flange connection due to several causes such as no proper alignment, insufficient torque on the bolts, too thin lens ring gaskets, lateral defects in the face of the lens ring or flange face, pipeline vibrations (reciprocating pumps, high pressure drops) or excessive stresses due to not proper piping design / installation. The picture below shows a typical leak of a lens ring flange connection.

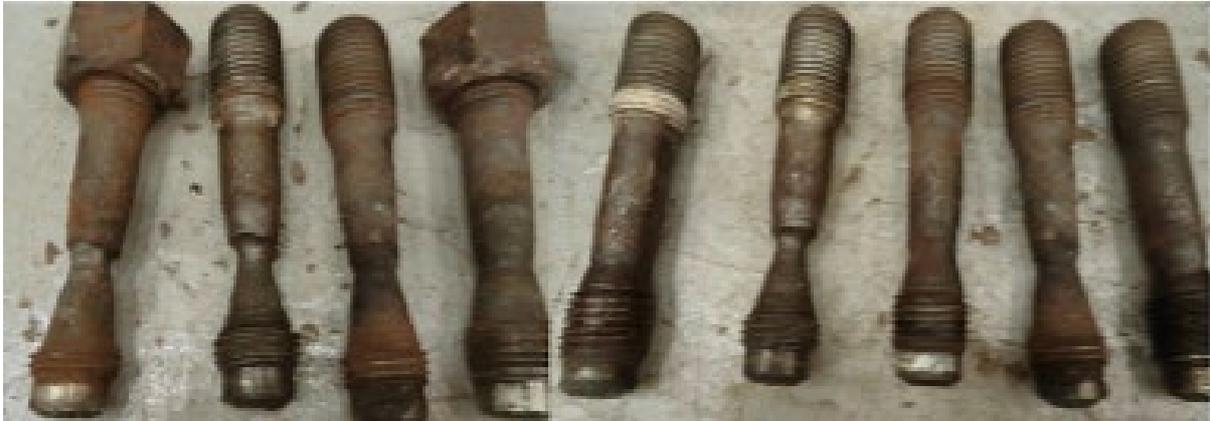
Figure 7: Corroded carbon steel bolts due to a leaking lens ring flange connection

Typically a leak cannot be stopped anymore because solids, which are formed during the flashing from high pressure to atmospheric pressure, will erode the leak path. Furthermore the leaking ammonium carbamate is extremely corrosive for carbon steel parts like the threaded flanges, bolts and nuts as shown in the picture below.

In case of a small leak one could consider to flush away the solids and dilute / absorb the ammonia from the leak by means of a continuous flush with steam and/or condensate. Monitor continuously the leak and integrity of the leaking equipment by means of a camera as even flashing ammonium carbamate can corrode carbon steel bolts and nuts. Refer to Figure 7.

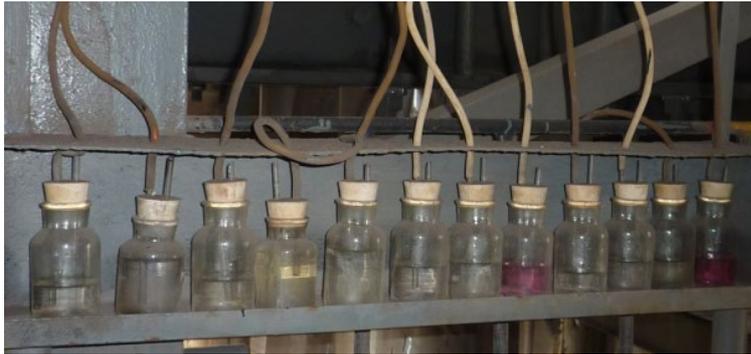
Figure 8: A typical passive leak detection system

Connecting leak detection holes with an ammonia detector and wait until the leaks shows up at the monitor (so called passive systems as shown in Figure 8) have proven not be reliable also as several serious incidents with these systems have been reported in the industry.[ref. 2]

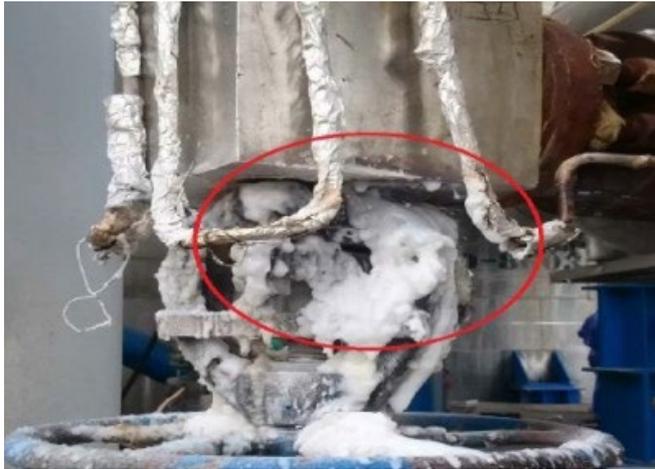
Figure 10: Leaks along a threaded bonnet connection of a high-pressure drain valve.

Threaded connections one can find in for example high-pressure valves (Figure 10) and high-pressure reciprocating pumps.

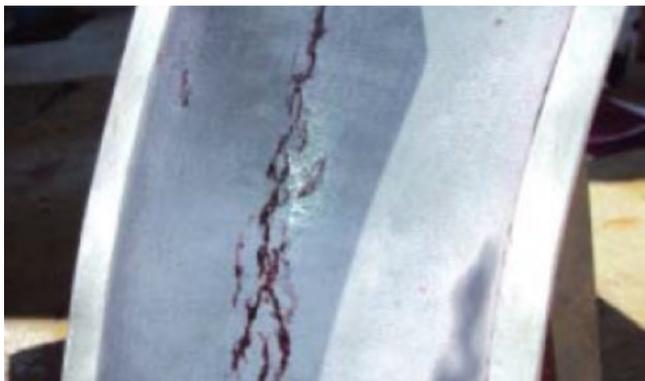
Figure 11: Cracks in a high pressure carbamate gas line.

Cracks are initiating leaks and a rupture will follow. Cracks can be caused by amongst others vibration issues, strain induced intergranular corrosion

of high pressure synthesis gas lines caused by a combination of stresses, large grain sizes of austenitic stainless steels and condensation of ammonium carbamate gases. Leaks due to cracks are critical as the leak size can grow suddenly leading to loss of integrity. It is recommended to shut down the plant in case one finds a leak caused by a crack.

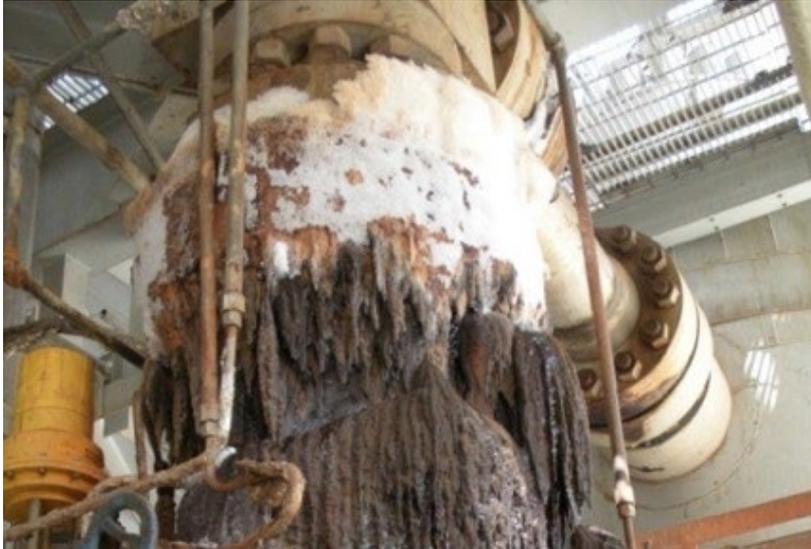
Figure 16: Solids have stopped the leak but created a critical unsafe situation.

Do not allow solids to form even if these reduce / stop the leak. One does not know what happens under these solids and corrosion ammonium carbamate still can corrode carbon steel parts and even stainless steel parts due to active corrosion as a result of lack of oxygen. Refer to Figure 16.
