RECONNECT

SYMPOSIUM 2022

Continuous improvement of high-pressure CO₂ stripper design

From inspections to re-design

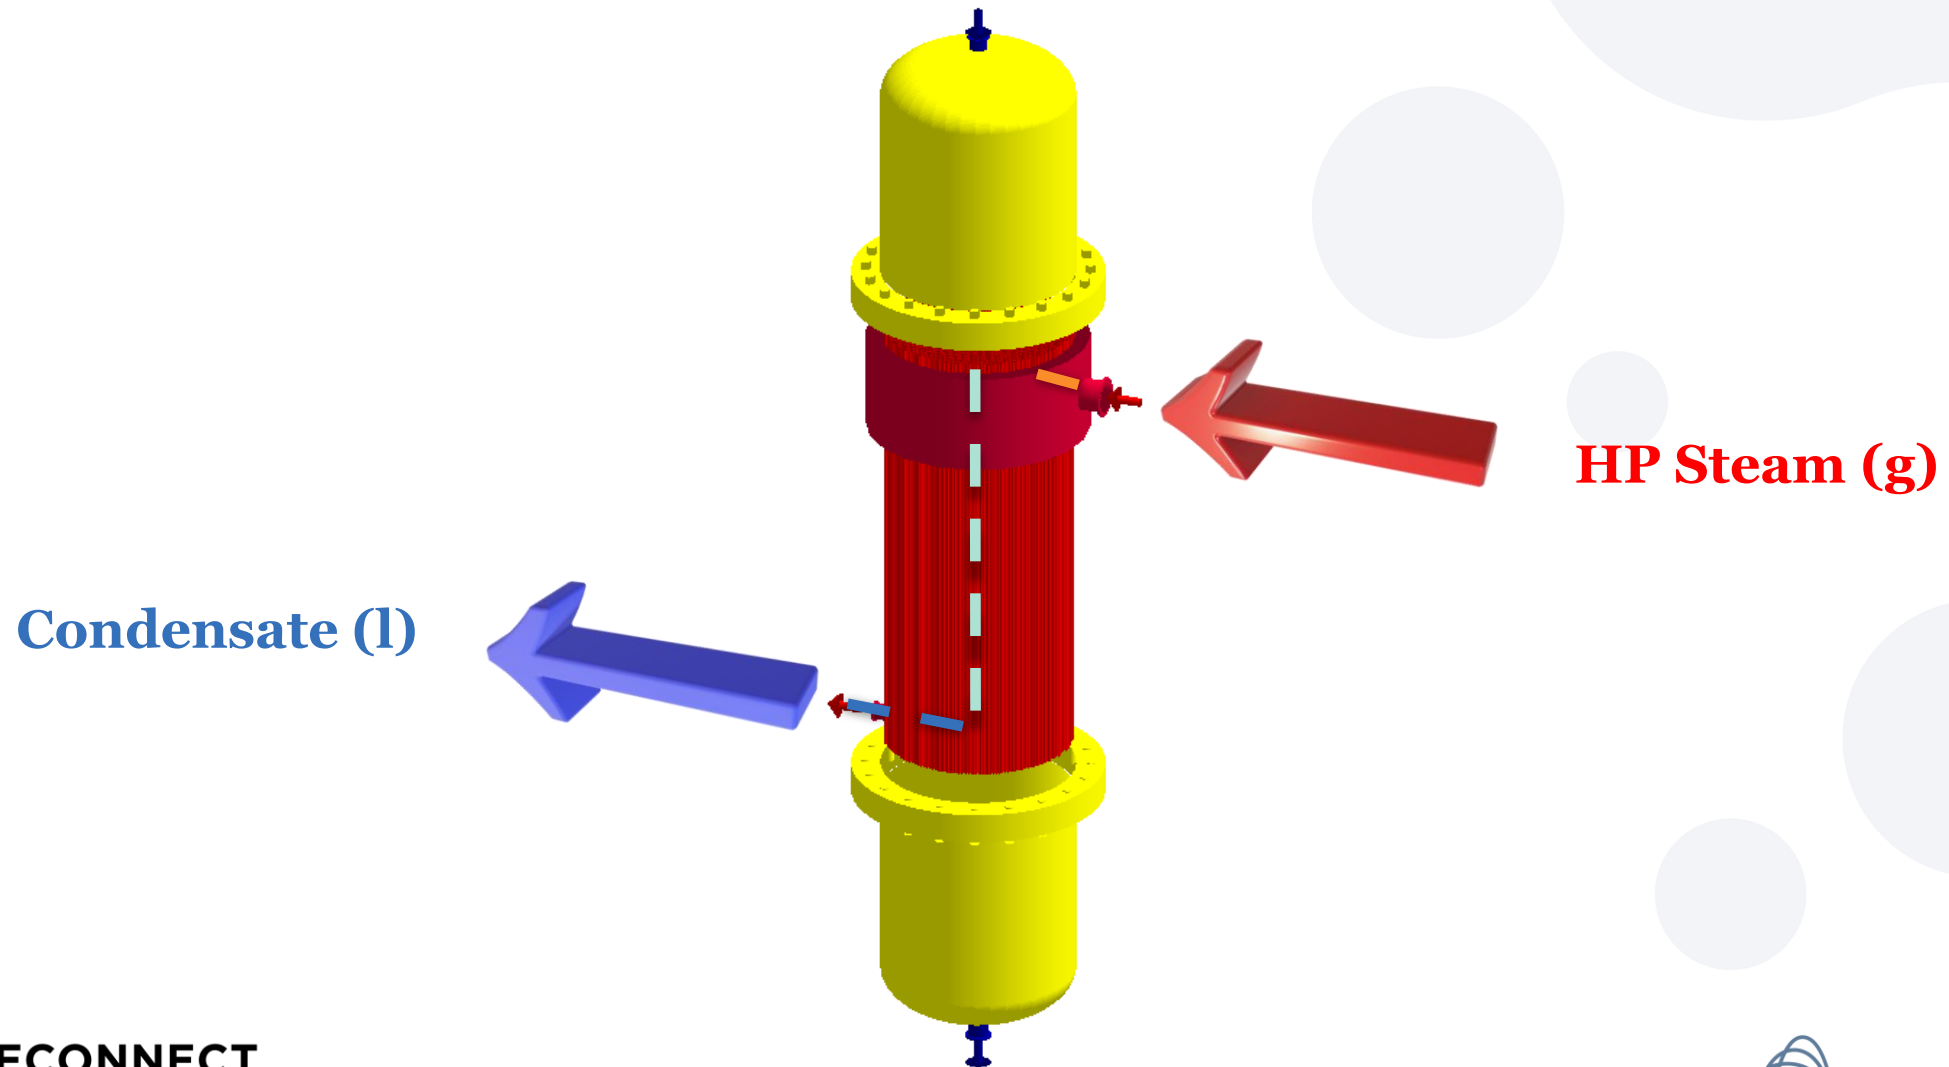
Urea solution (l)
(USO)

CO₂ (g) + stripped carbamate
(NH₃, CO₂)

CO₂ (g)

Purified urea solution (l)

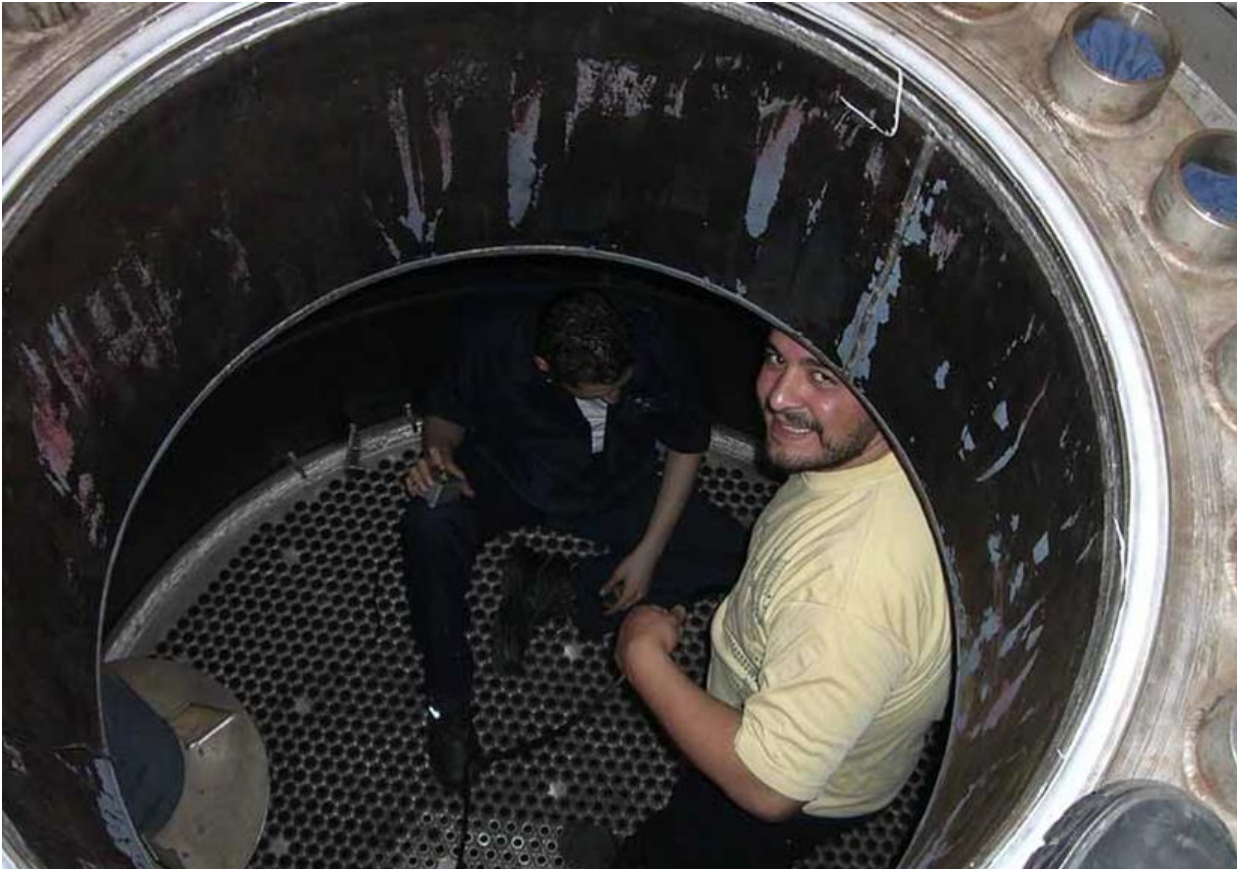
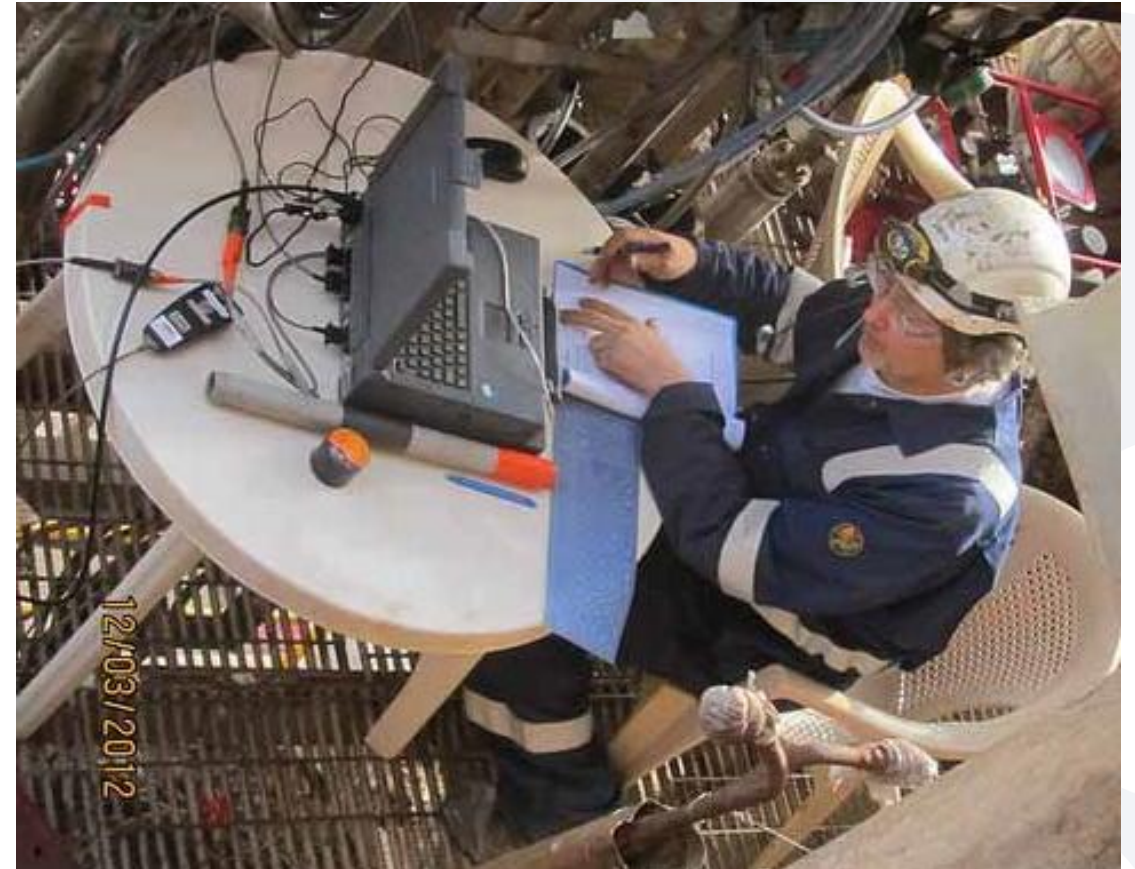
Inspection of HP Stripper Tubes

- In general, HP stripper tubes do face the highest temperatures in urea plants
- As a result, in general, stripper tubes do face the highest corrosion rates in urea plants

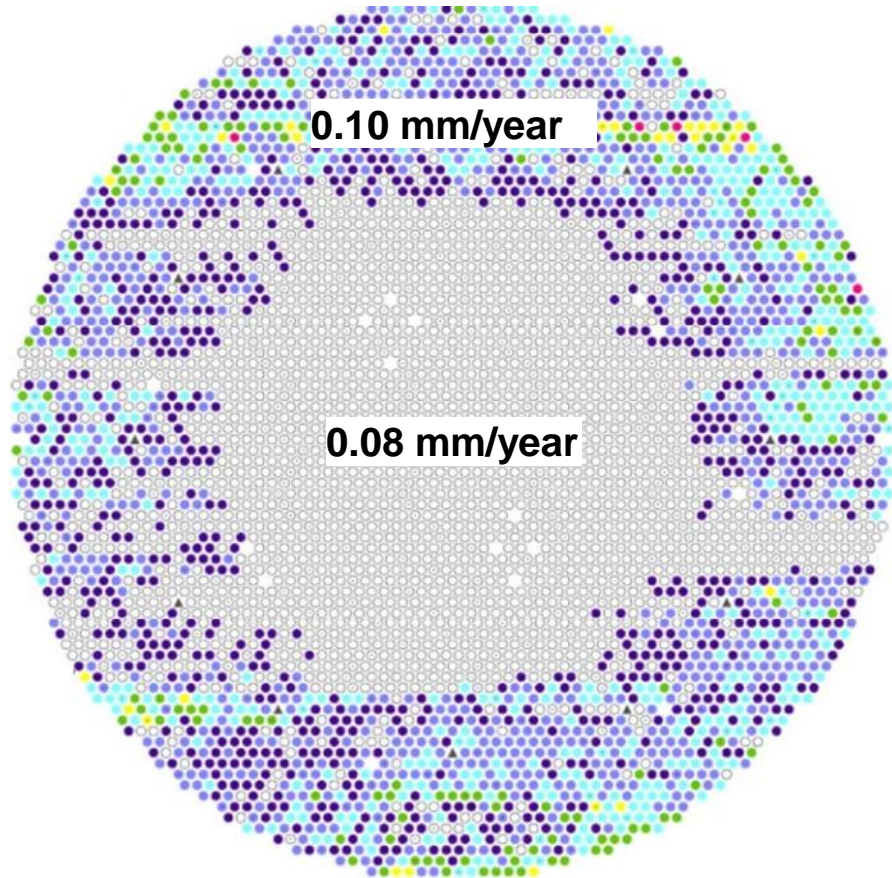
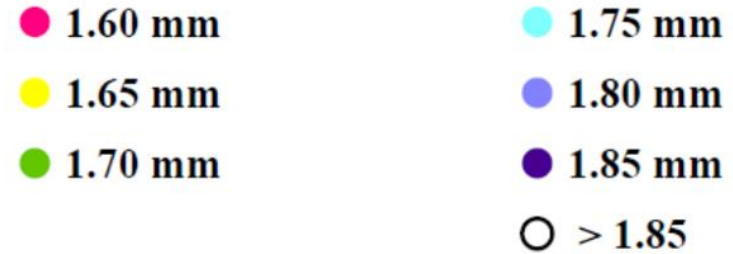
First observations

Peripheral enhanced corrosion

Stripper was in operation
for 12 years

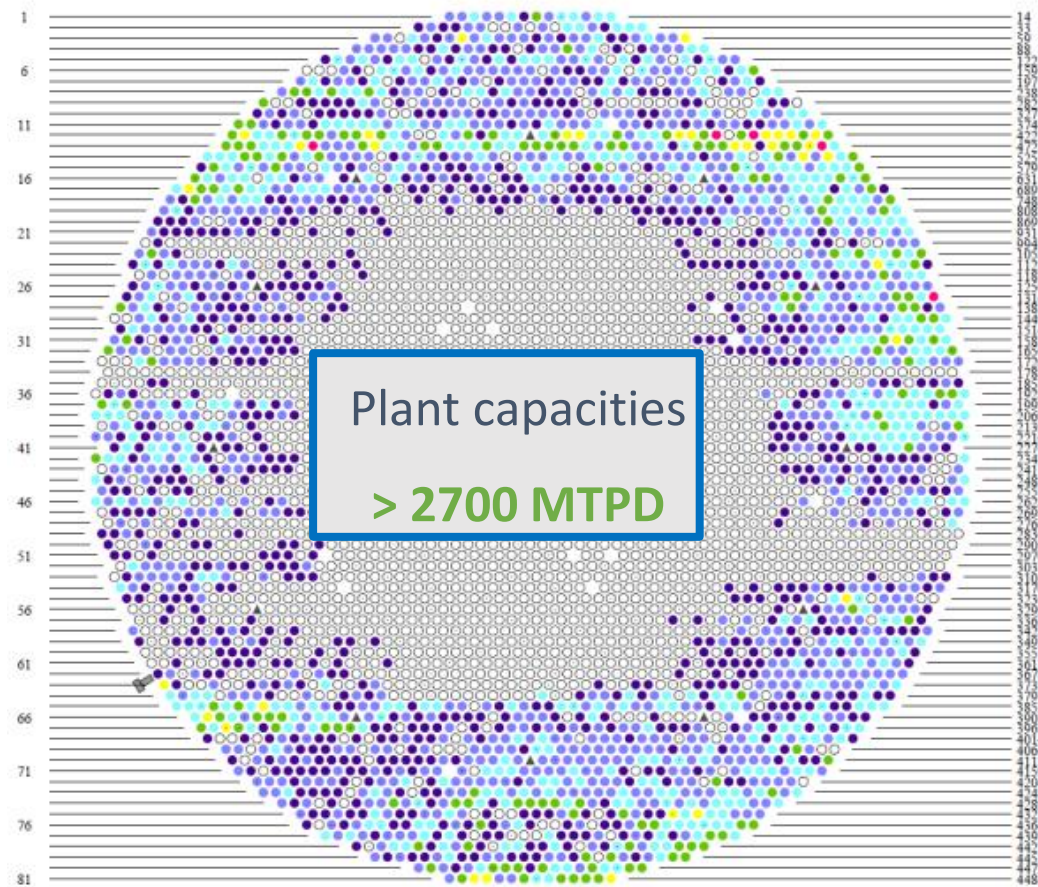
After more inspections at different clients, we could conclude the following:

- **Peripheral corrosion is not related to the material of construction**
- **Peripheral corrosion is only taken place at large capacity plants**

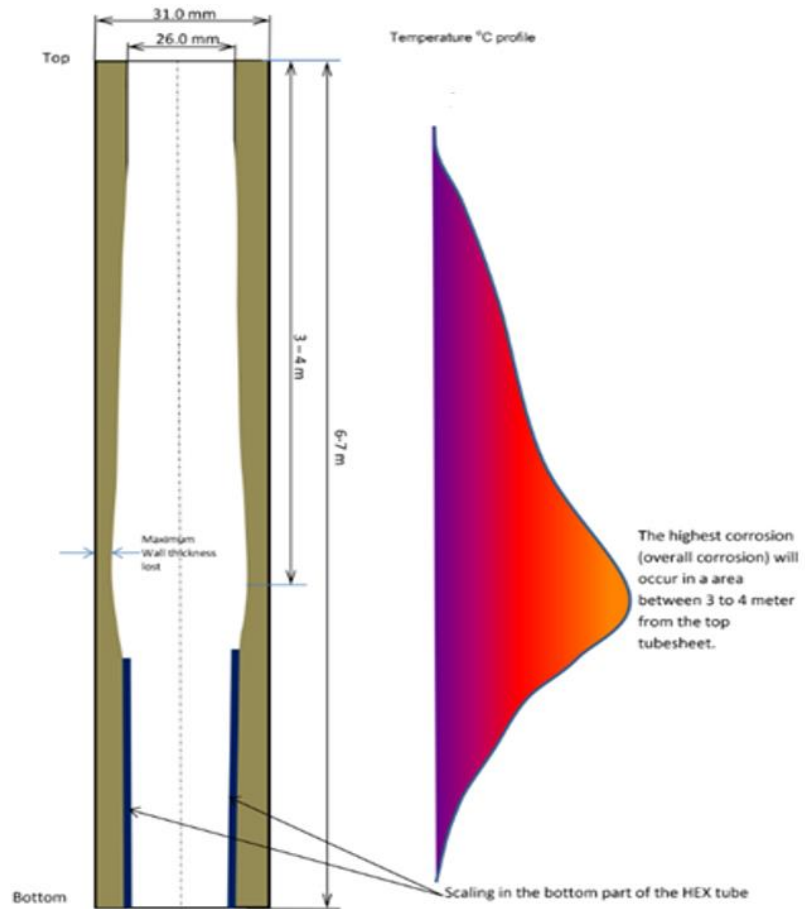
No scaling on center tubes

Looking to tubes more in detail:

- In the tubes in the centre there was no iron oxide scaling.
- In general, the more carbamate is decomposed the more iron oxide will precipitate to the tube wall

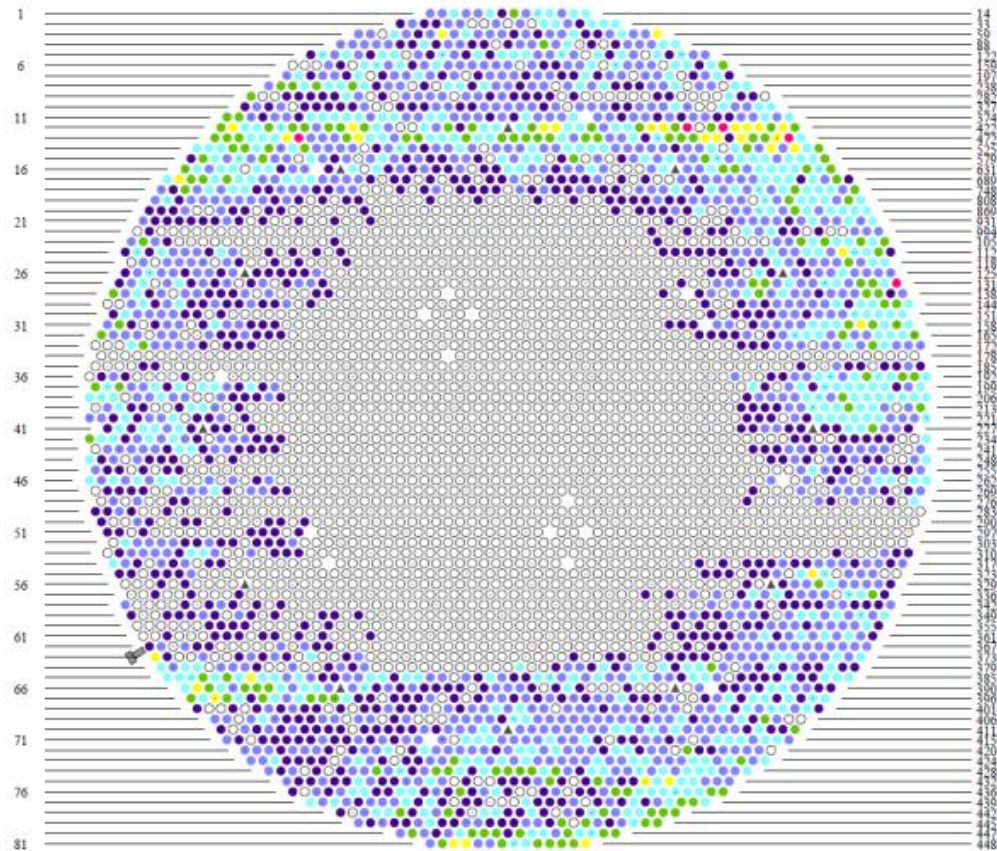
Additional observations

- The stripping efficiency between the tubes located at the inside periphery and the outside periphery is increased.
- At plants operated above name plate capacity and high onstream times the effects are more severe.

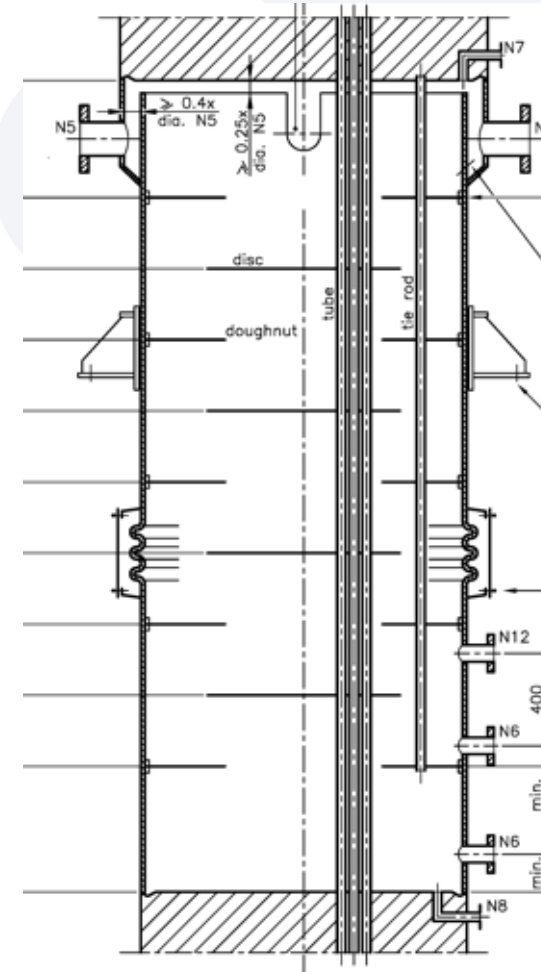
Radial maldistribution of *heat*: analysis shell

- Standard Disc & Doughnut design
- Only steam & condensate
- 100% condensation, no inerts

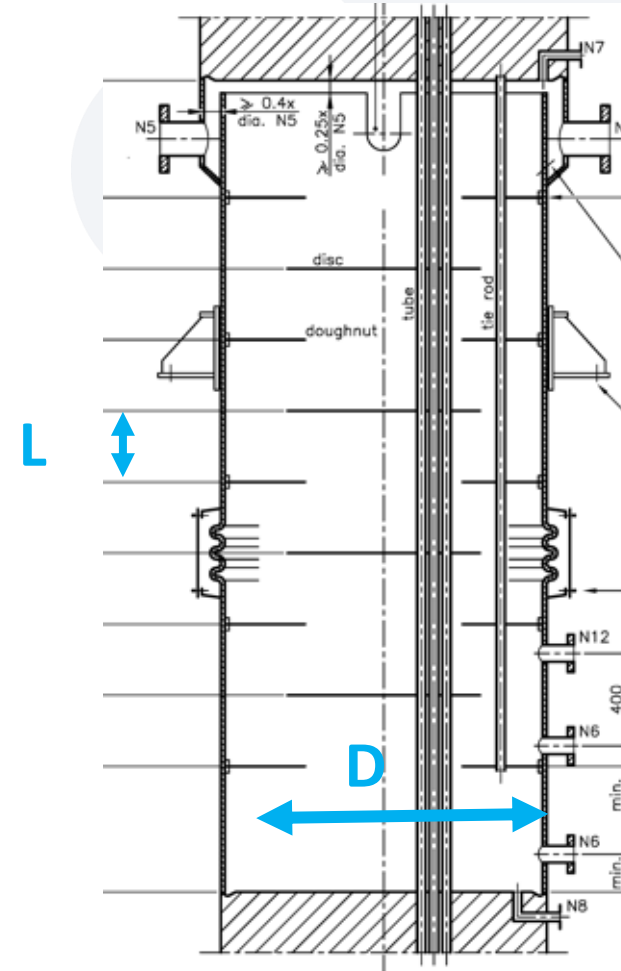
Radial maldistribution of *heat*: scaling up

- Distance between baffles is fixed, baffle cut is % of the shell diameter
- Upscaling is leading to a lower L/D baffle ratio -> higher radial velocities

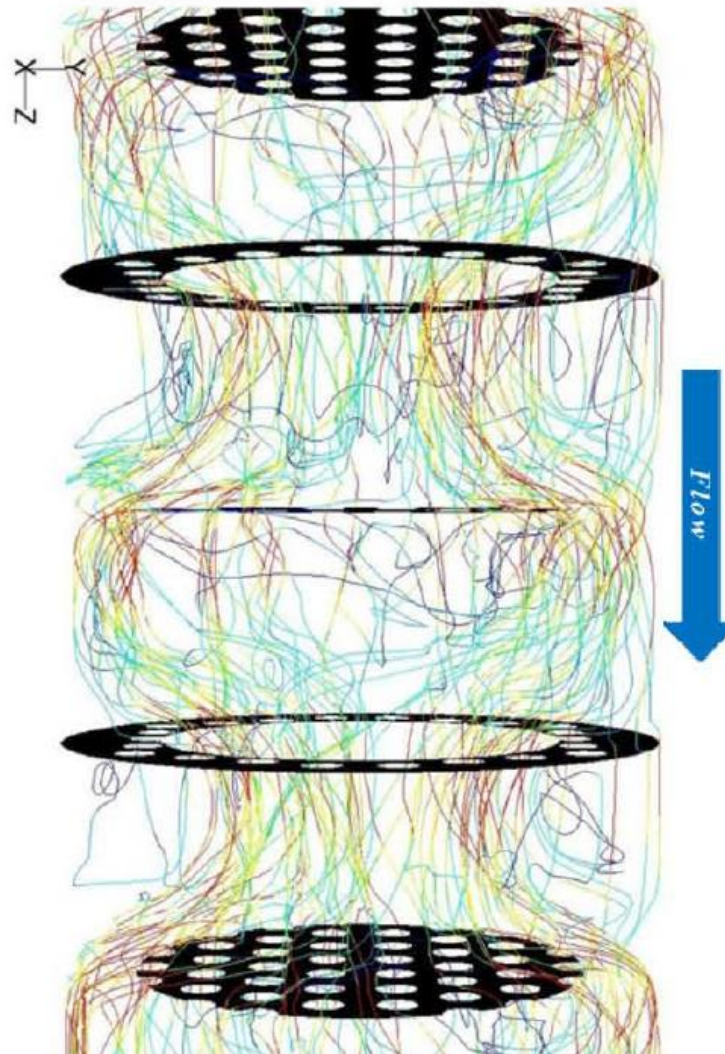
Radial maldistribution of *heat*: scaling up

Image out of a HTRI study, indicates flow patterns of a **non condensable** vapor

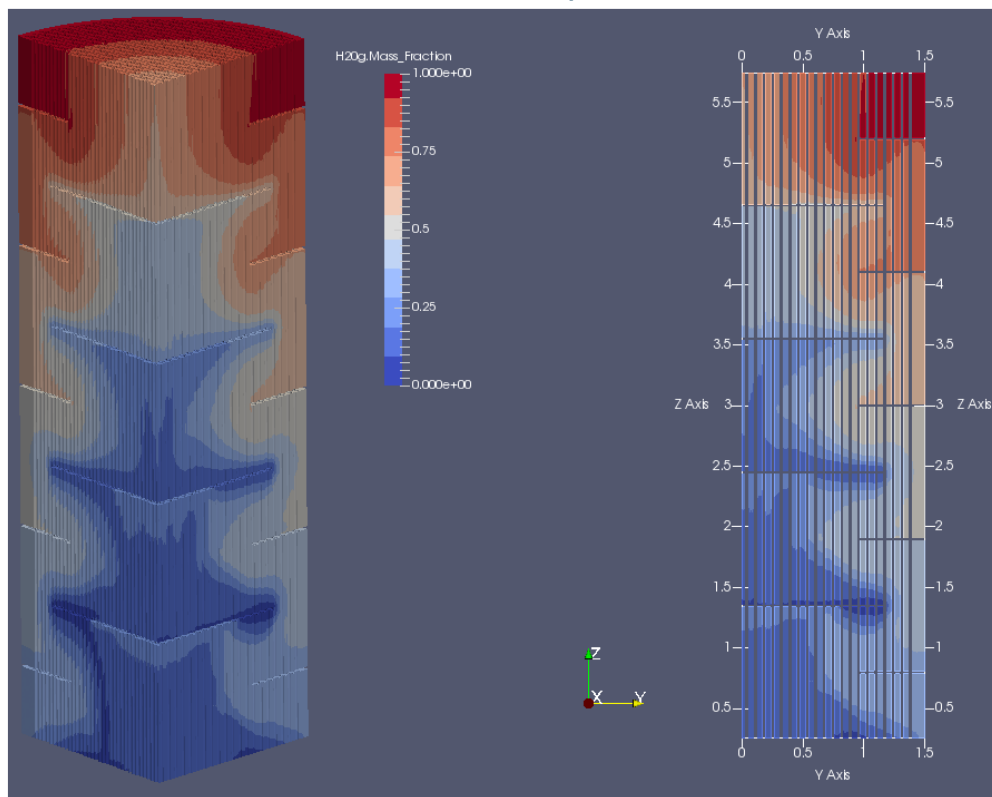
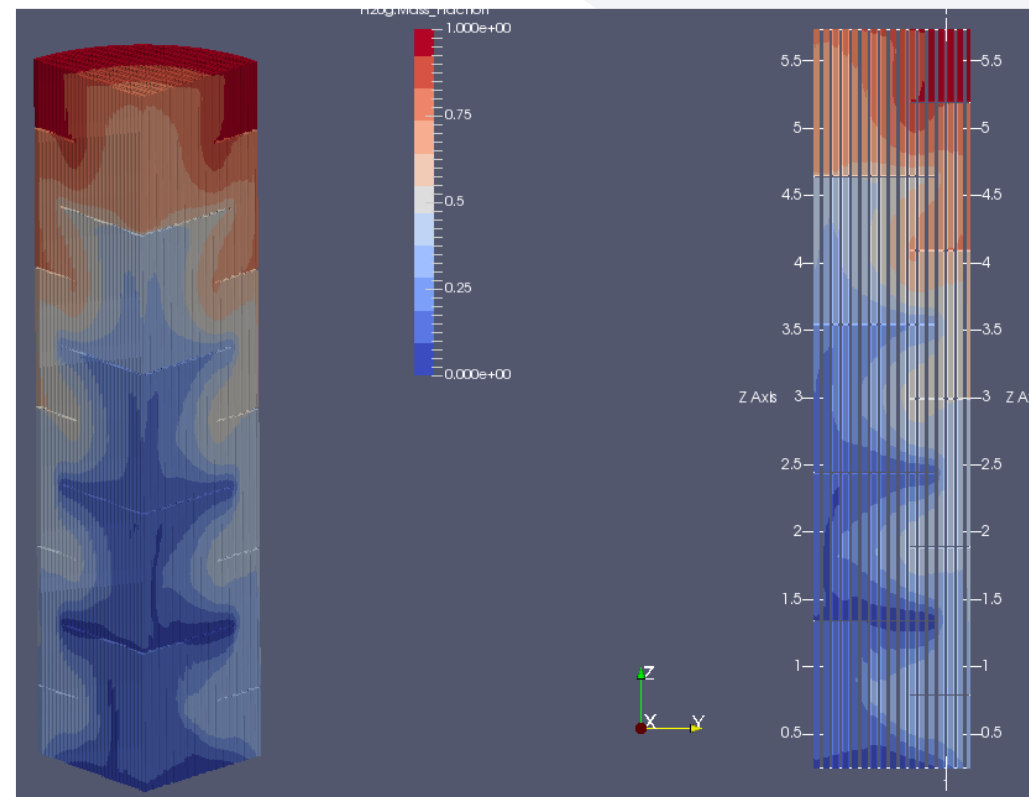
CFD Water Mass Fraction: accumulation

LARGE SCALE $\phi \sim 3$ m

SMALL SCALE $\phi \sim 2$ m

Condensate accumulated in last 3 disks.

Bigger strippers more trouble discharging condensate than smaller ones.

- Accumulation of condensate on disks (main RC)

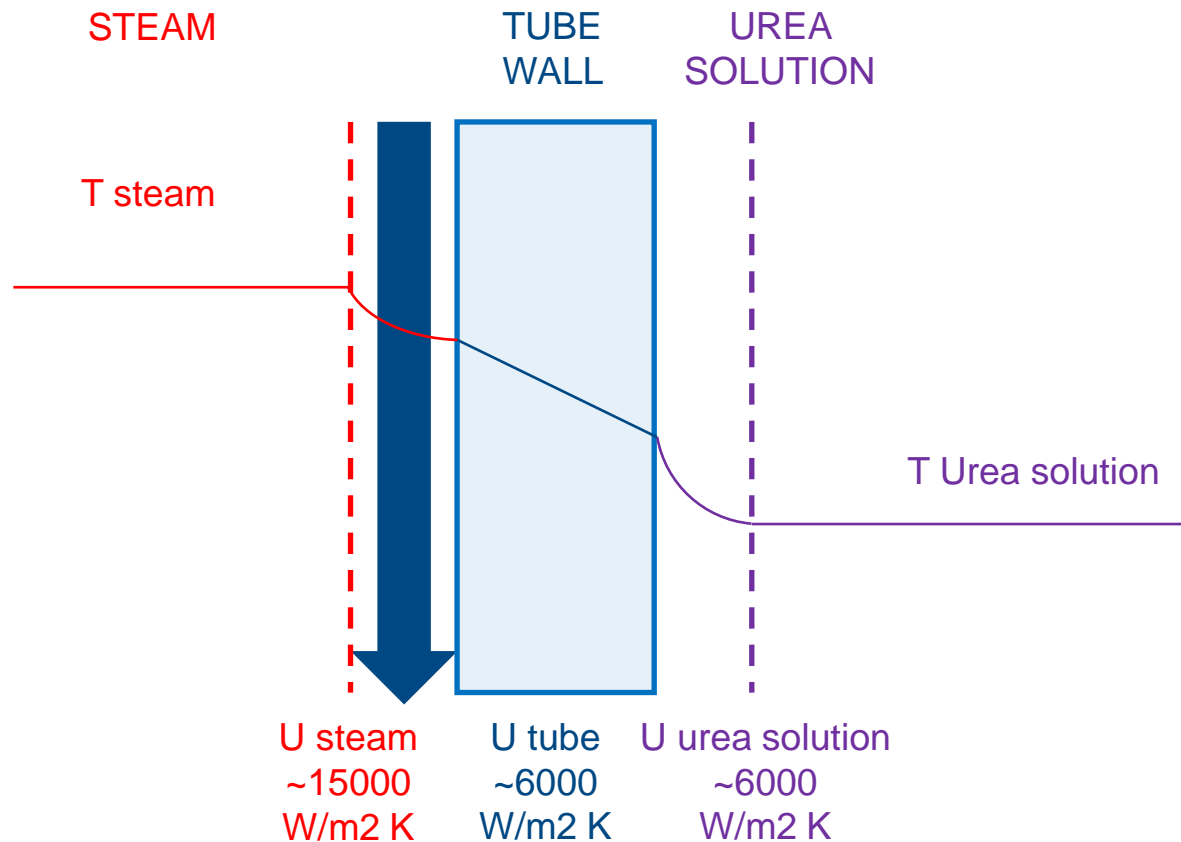
Temperature profile & overall heat transfer coefficient (U) in HTRI (order of magnitude)

U_{TOTAL}
2500 W/m² K

Gravitational
flow of condensate

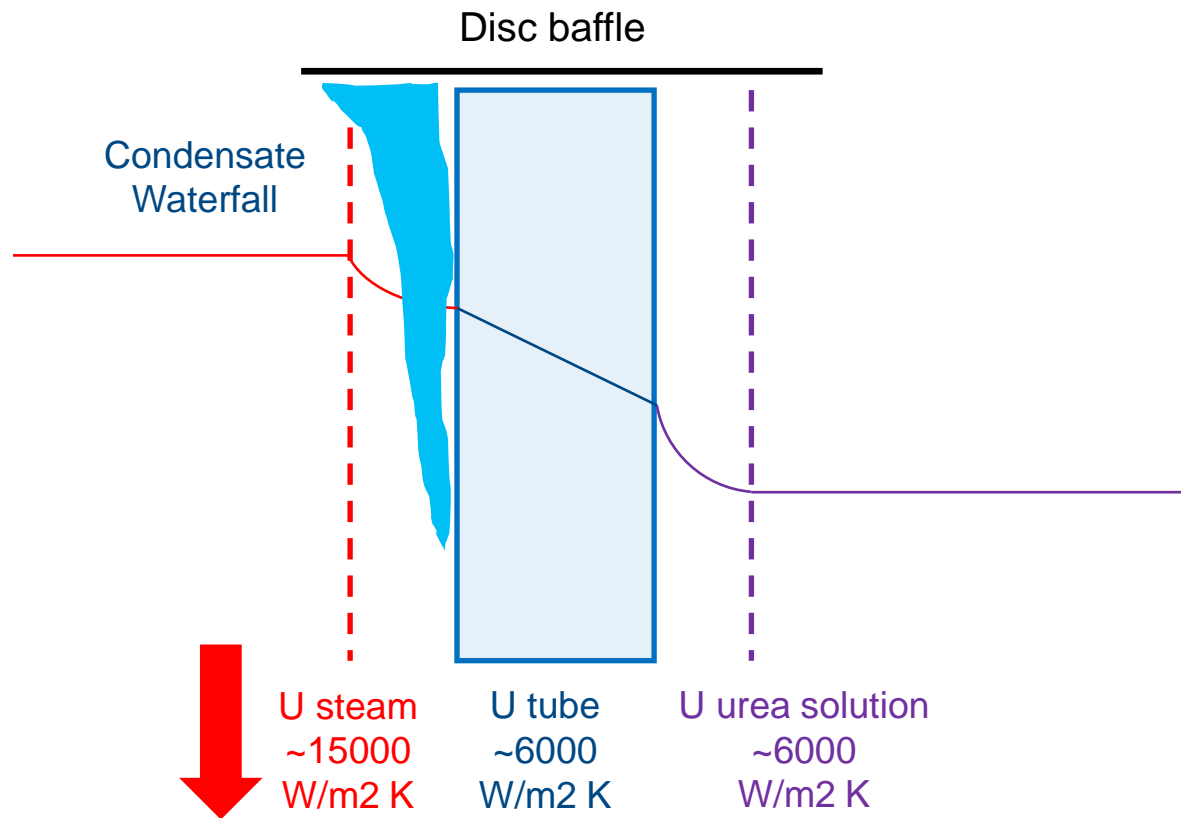
Temperature profile & overall heat transfer coefficient (u) in HTRI (order of magnitude)

U_{TOTAL}
2500 W/m² K

Decreased
heat transfer

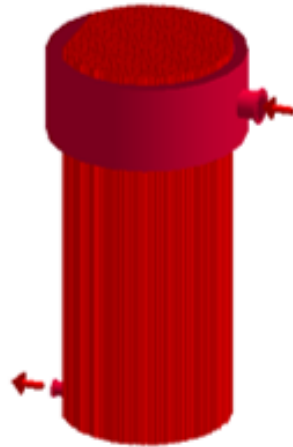
Root Cause

Lower overall heat transfer
to the tubes in the center
area of the shell side due to
water accumulation

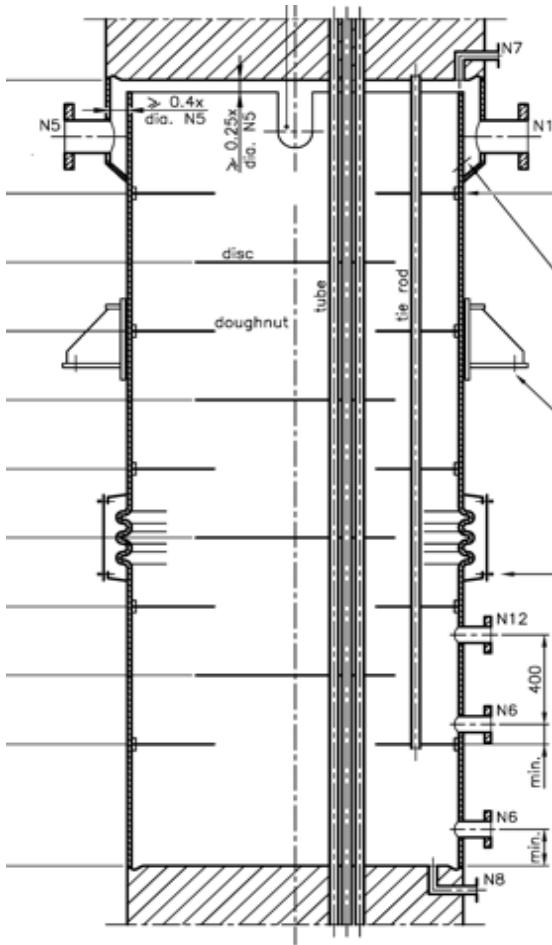
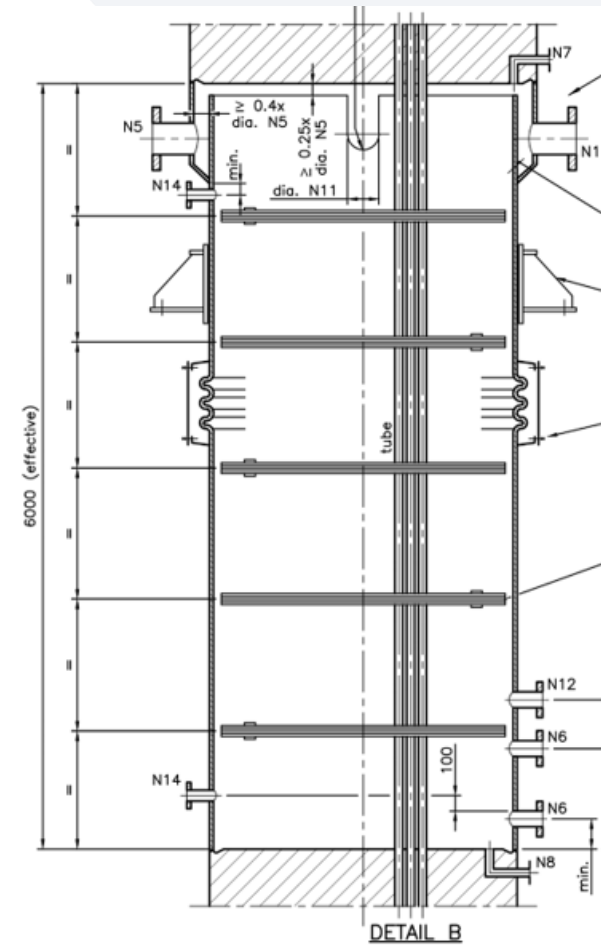
New HP Stripper Design

GRIDS

Open area evenly distributed
over section so water
homogenously discharged

Redesign from D&D to grids

- Grids support tubes and discharge condensate accumulation
- HTRI predicted improved overall heat transfer coefficient

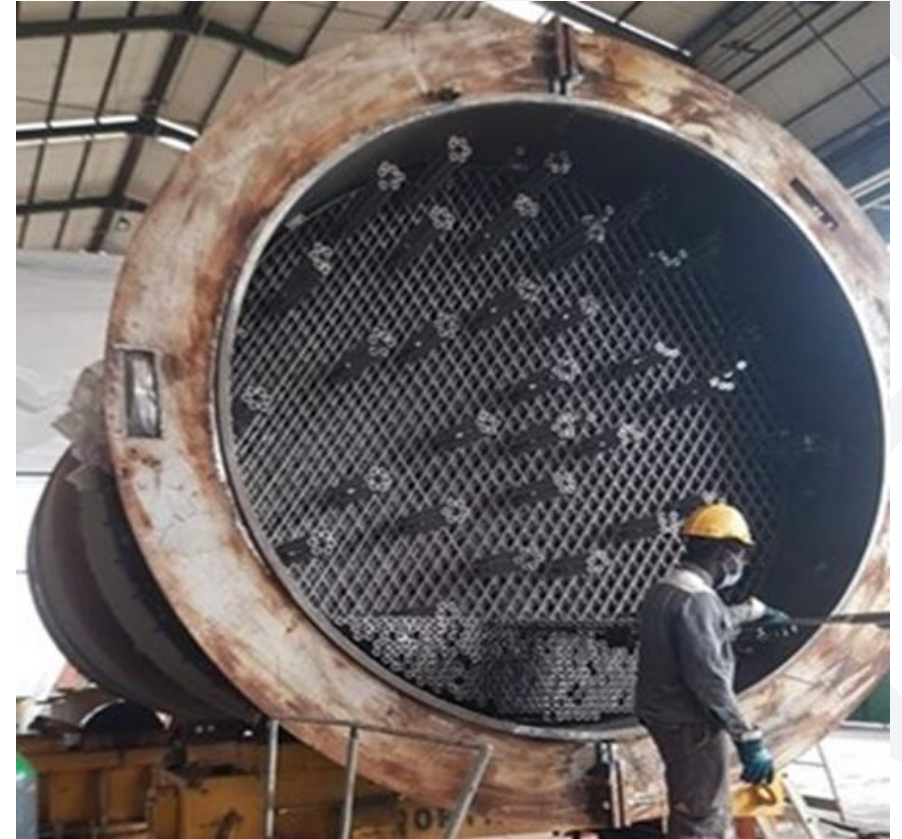
New HP Stripper design: Grids

Advantages

- Condensate discharge uniform, eliminating waterfall effects
- Heat transfer distribution more homogeneous

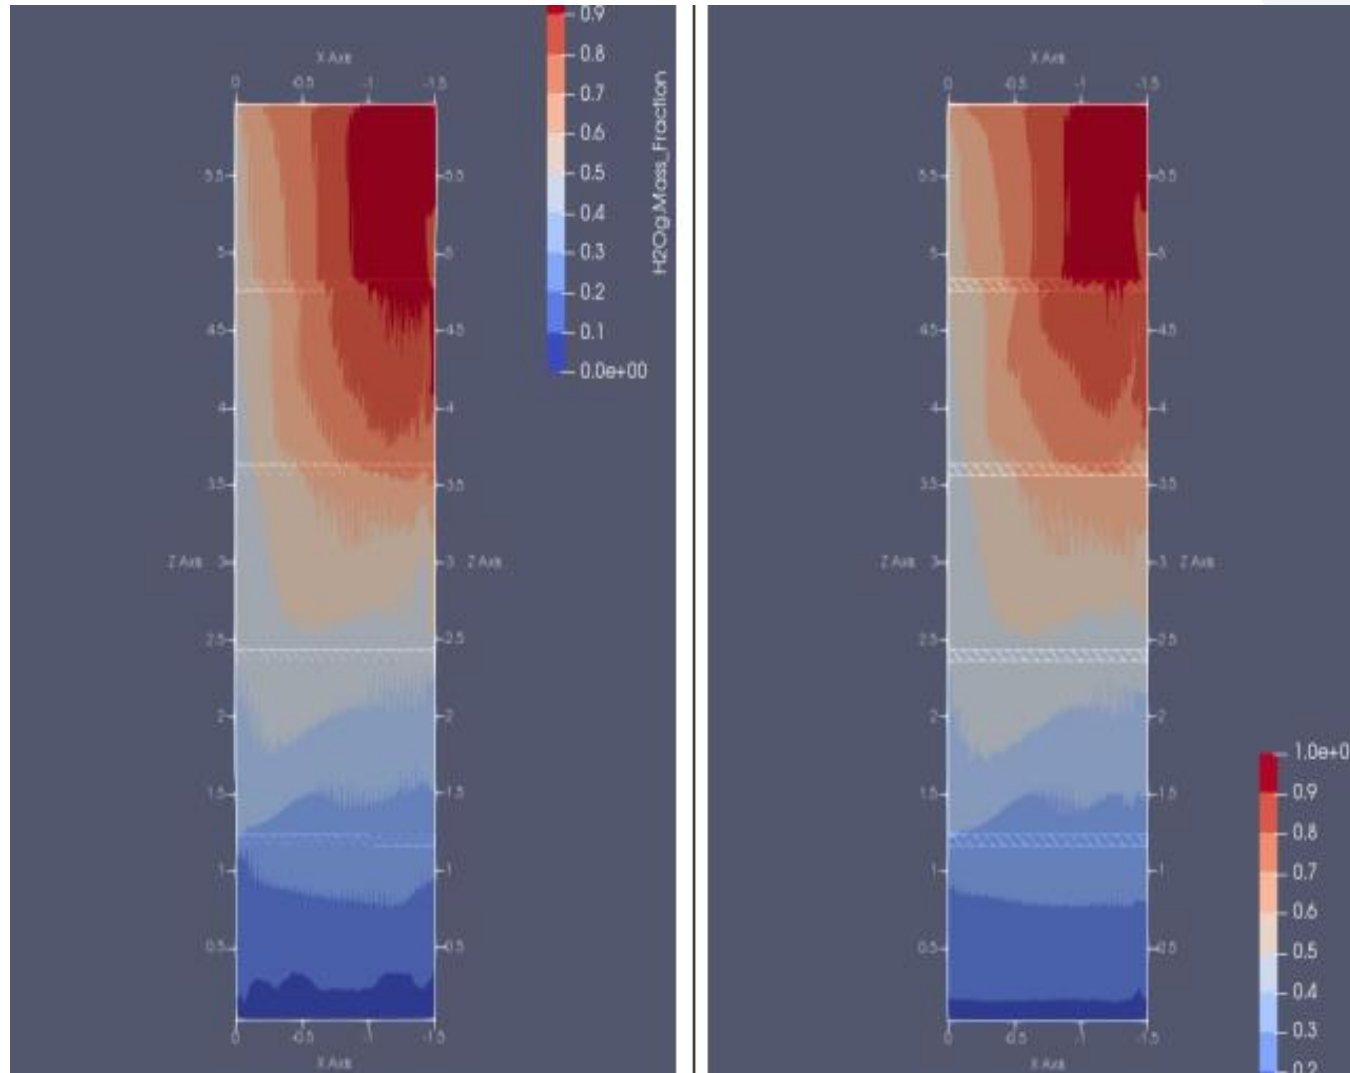
CFD Grid Design

Mass FR. & velocity for 2 pitches: replacement & grassroot

No condensate accumulation

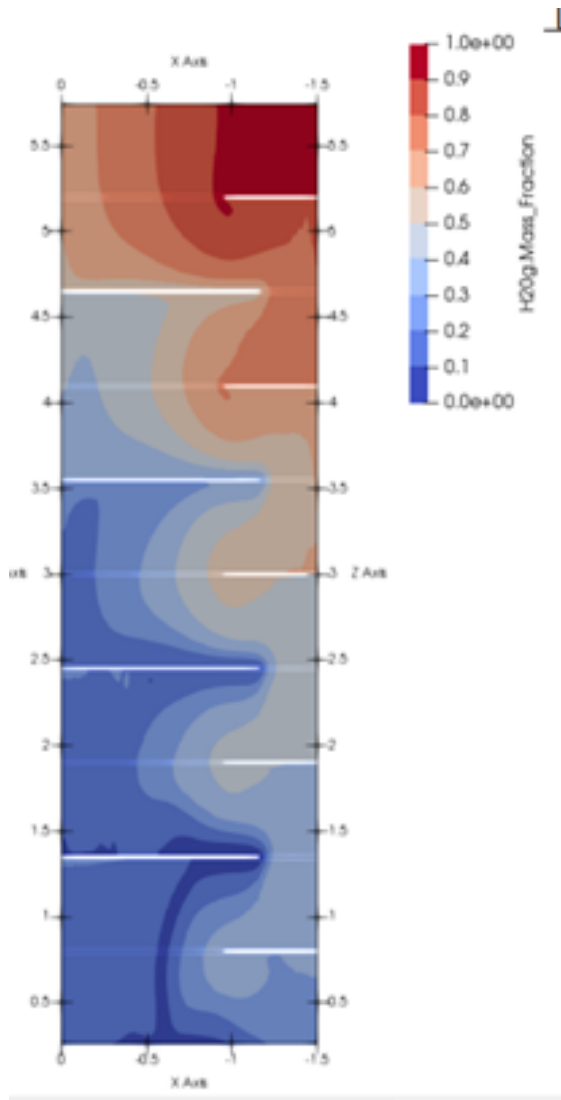
CFD VAPOUR fraction

mass fraction

vapor fraction

Vapor fraction much
larger than mass
fraction
due to density
differences.

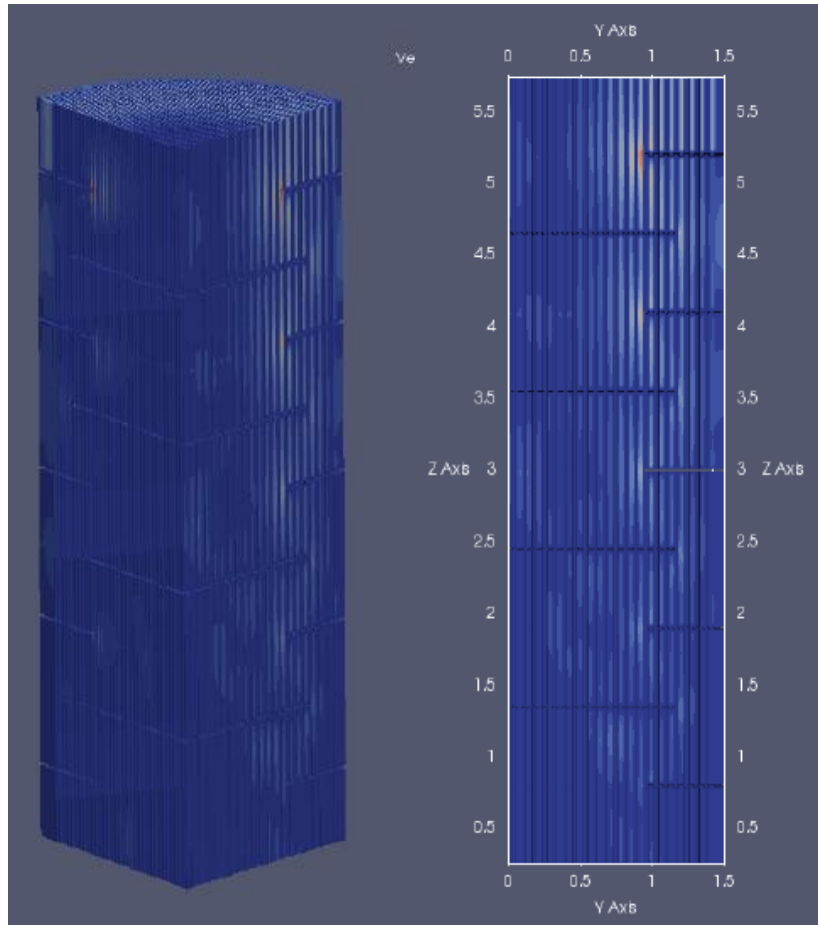
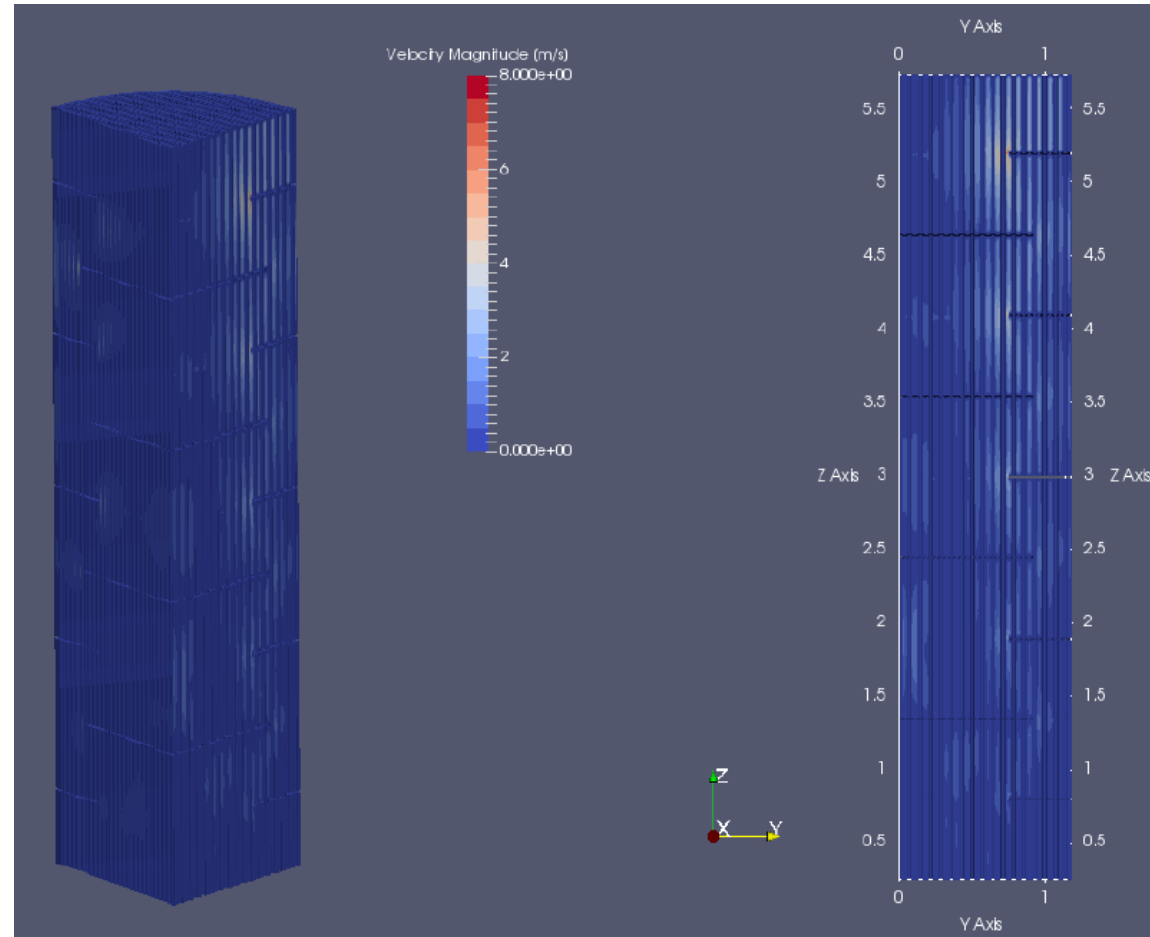
CFD VELOCITY profiles

LARGE SCALE

$\sim 2 \text{ m/s}$

SMALL SCALE

Small velocity differences radially
