Middle East Nitrogen + Syngas 2019

REPAIR OF A HP SCRUBBER DAMAGED BY CORROSION

Stamicarbon Workshop
Middle East Nitrogen +
Syngas 2019

Alex Scheerder, Stamicarbon, The
Netherlands
October 2019

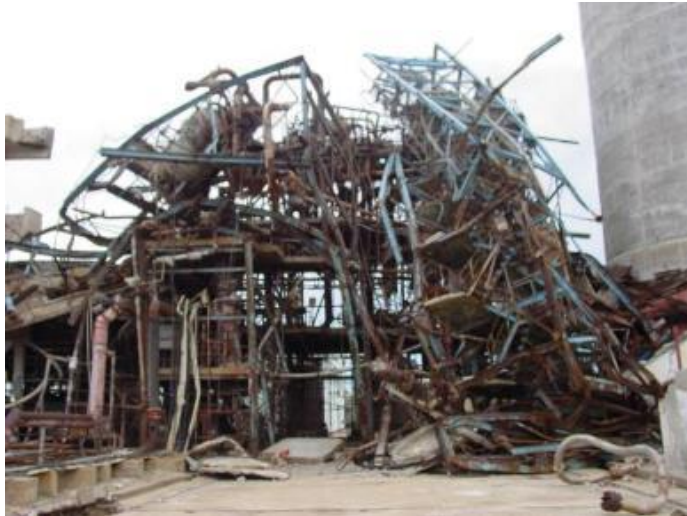
- Catastrophic failure urea reactor (100 mtpd)
- Unnoticed leakage through stainless steel barrier
- Affected the carbon-steel pressure shell
- Break-Before-Leak Scenario
