CASE STUDY

CATASTROPHIC FAILURE OF A UREA REACTOR

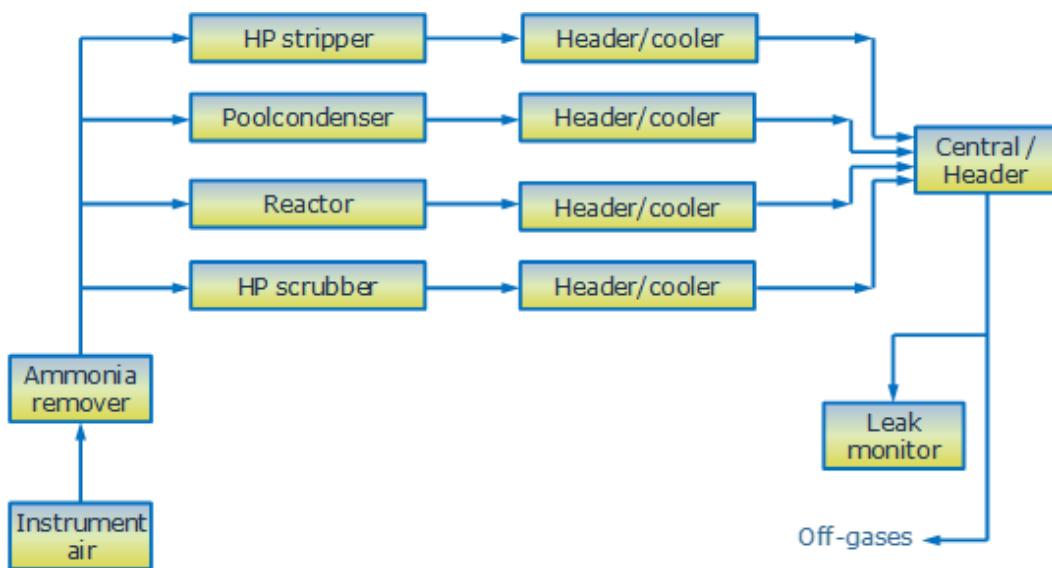
In 2006 a state-of-the-art leak detection system was installed to monitor all high-pressure urea synthesis equipment in this plant. The principle of the leak detection system is to circulate dry air behind the liner compartments of all connected equipment and to analyze the received air for presence of ammonia. The principle is schematically presented in figure 2. The leak monitor is connected to the DCS system in the control room.

Figure 2: Principle of leak detection system, circulating dry air to all connected equipment.

The pinhole leak in the liner created severe corrosion attack of the c-steel pressure shell and the reactor was put out of service just in time. The state-of-the-art leak detection however failed to indicate the leak; this was due to a combination of wrong commissioning of the system and failure of some components; thus, insufficient inspection and maintenance of the system.
