RECONNECT
SYMPOSIUM 2022

Importance of proper BFW quality in Pool Condenser plants

Conference name Stamicarbon Symposium 2022 – Reconnect
Conference date 16th – 19th May 2022
Author(s) Alex Scheerder and Bart Gevers
Classification Public

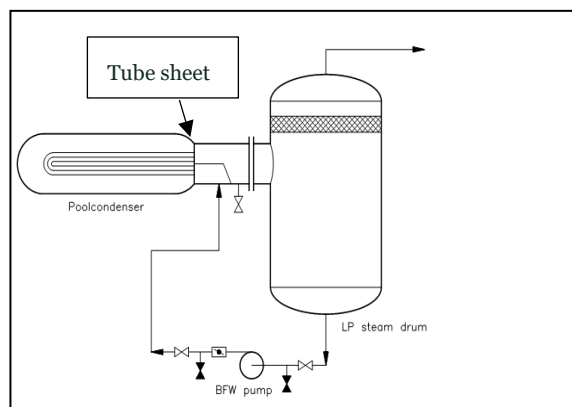
The Pool Condenser is a horizontal shell and tube heat exchanger, equipped with a U-bundle, see figure 1. The U-tubes (X2CrNiMo25-22-2, BC.05) are connected to the tube sheet by a so-called internal bore weld (IBW). The tube sheet is made from 20Mn5V carbon-steel with a thickness of 425 mm + 22 mm X2CrNiMo25-22-2 weld overlay.

Figure 1: Pool Condenser and LP Steam Drum

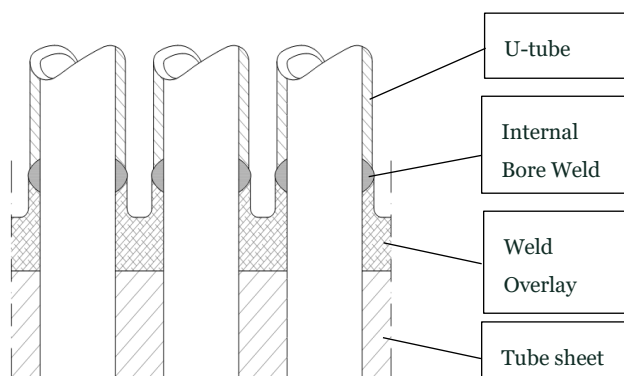
The inner diameter of the holes in the carbon steel tube sheet is Ø 19 mm. The internal bore weld (IBW) connecting the U-tube to the weld overlay on the tube sheet is schematically presented in figure 2.

Figure 2: Internal Bore Weld connection of U-tube to the tube sheet; connected to the X2CrNiMo25-22-2 (BC05) weld overlay

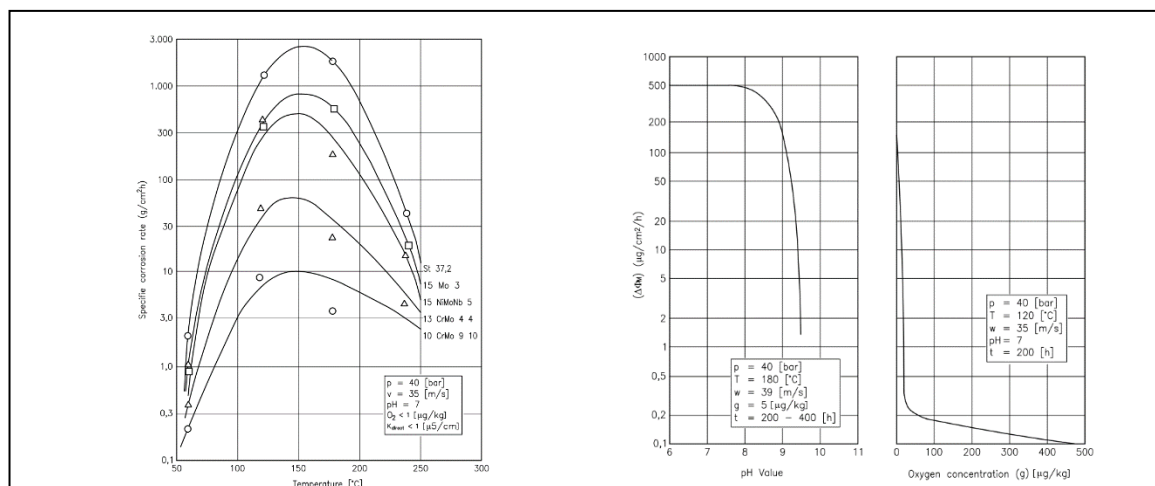
In figure 11 and 12 (source: [ref 6]) the effect of temperature, pH and oxygen content on the resistance to erosion-corrosion is demonstrated.

Figure 11: Formation of protective layer is poor at 150 °C (LP steam temperature)

Figure 12: High protection at pH > 9.5 and Oxygen content > 10 ppb

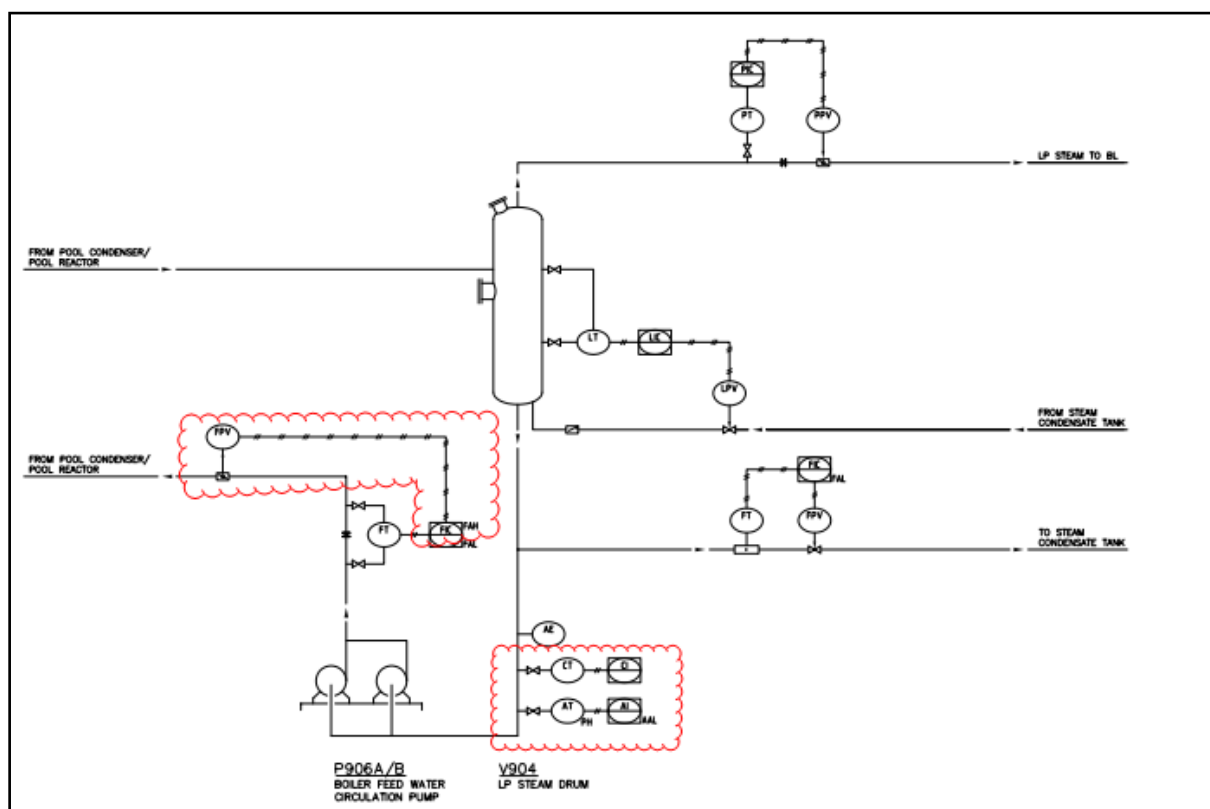
It is the pH of the steam condensate from the U-bundle to LP steam drum V904 which should be minimum 9.5. It is not possible though to sample/measure that particular stream. The pH of the BFW from LP steam drum V904 to the U-bundle is however virtually the same as the pH of the steam condensate from the U-bundle. Therefore Stamicarbon introduced an on-line pH measurement in the suction of BFW pump P906 – see figure 13.

Figure 13: Changes in P&ID to accommodate proper control of the BFW quality and flow

Apart from the water chemistry, which is of primary importance, Stamicarbon also reduced the design steam to condensate exit ratio from 2 to 1 kg/kg. Also Stamicarbon introduced a flow control in the BFW circulation loop to the Pool Condenser/Pool Reactor for the BFW flow to be controlled as per design – see also figure 13. These two measures are to limit the amount of steam condensate leaving the U-bundle. This has no meaning for the tube sheet outlet of the U-bundle when duplex sleeves are installed – see paragraph 4.5, but still have a positive effect on erosion-corrosion in the LP outlet channel of the Pool Condenser/Pool reactor and in LP steam drum V904.

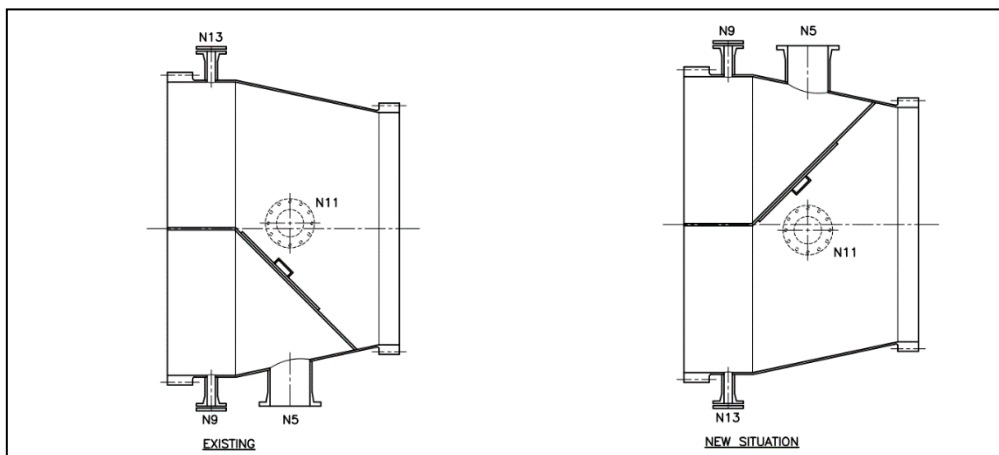
Figure 16: existing design (left); water inlet box at bottom tube sheet; (left) and modification, water inlet at top tube sheet (right)

Scenario 2. The tube sheet strength does not meet the design requirements, but the tube sheet is still fit for use based on the FEM assessment. In this case, it is advised to completely stop any further erosion-corrosion damages in the outlet part of the tube sheet, by changing the outlet side to the bottom part of the tube sheet. The upper part will become the water inlet side and further erosion-corrosion damages at the affected top side will be avoided, see figure 16.

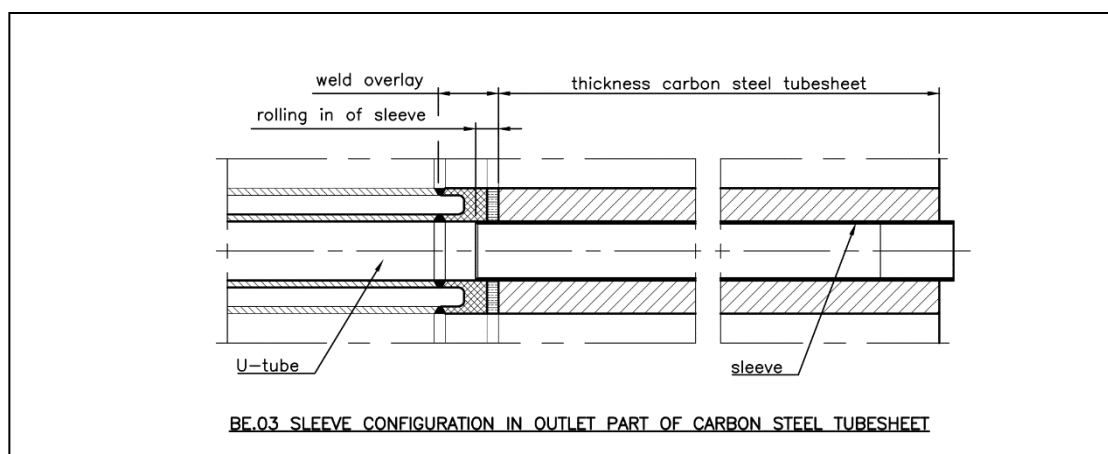
Figure 17: In-situ installation of duplex sleeves (BE.03) to protect the tube sheet holes from erosion-corrosion

The bottom side of the tube sheet can be protected for erosion-corrosion by installing duplex stainless steel sleeves (BE.03), see figure 17.

This repair strategy is already executed in two Pool Condensers and several other repairs are planned. To date both of these sleeved Pool Condensers have been inspected and the sleeves perform well and still in place, see figure 18.
