Importance of proper boiler feed water quality in Pool Condenser / Reactor plants

Alex Scheerder

18 May 2022

Introduction and background

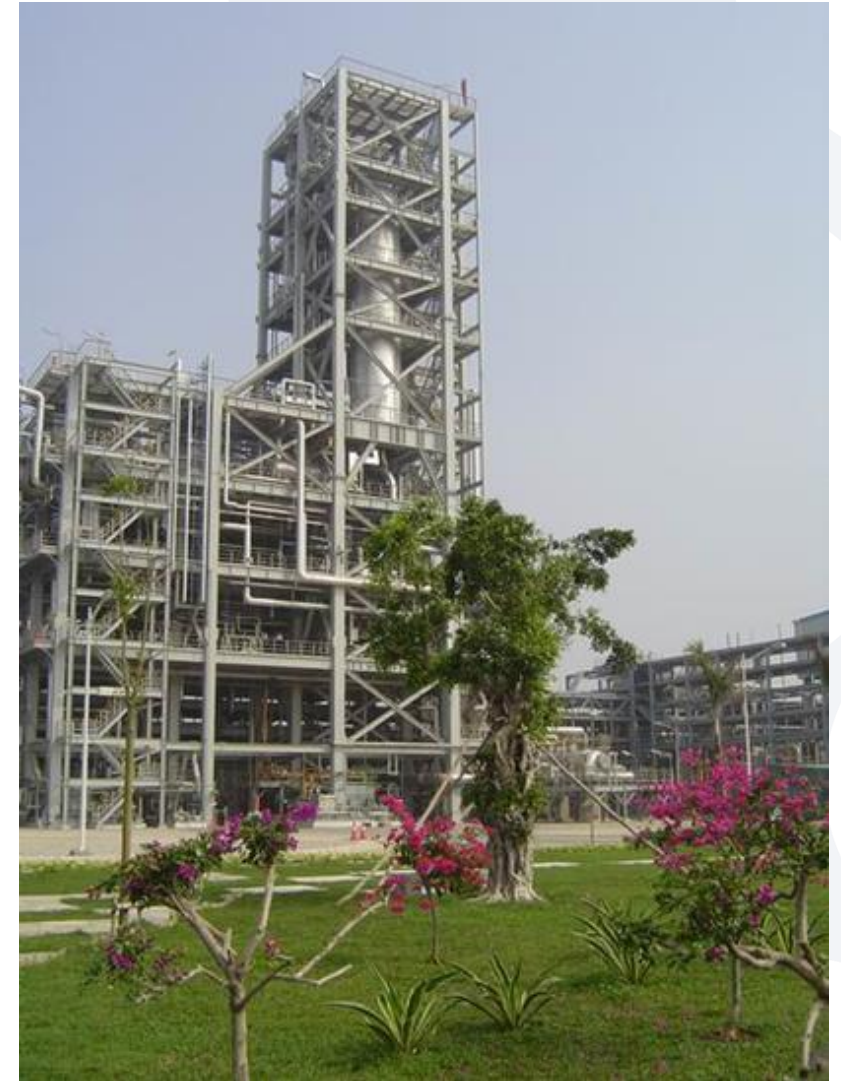
- Unexpected damage occurred in a Pool Condenser in 2016:
 - 2700 mtpd CO₂ stripping plant
 - Commissioned in 2003
 - Materials of Construction: X2CrNiMo25-22-2
- Integrity of the tube-sheet was affected at steam side
- Not related to corrosion at process side
- Complicated, expensive and time-consuming repair was needed
- Equipment replaced within two years

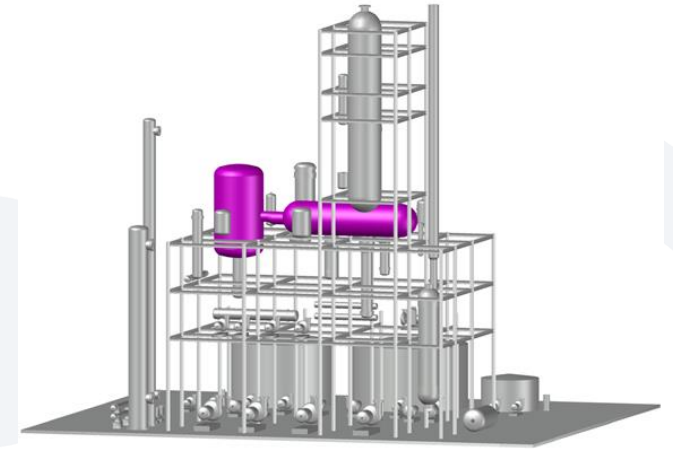
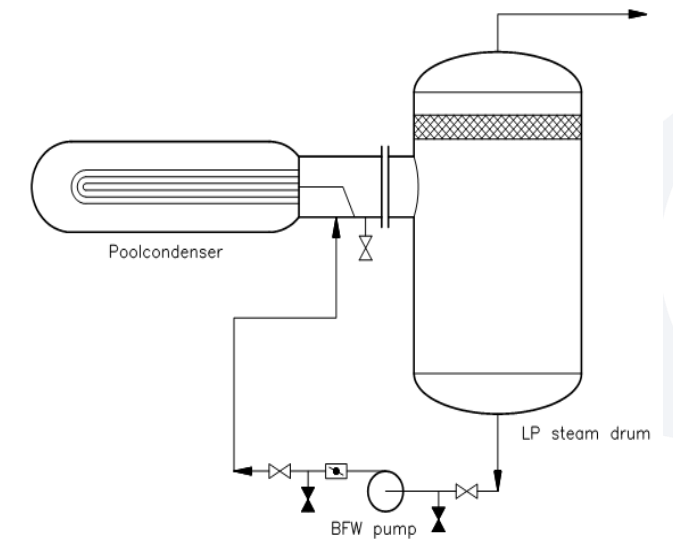
- Pool Condenser plant based on old Urea 2000plus™ Technology
- Low pressure steam drum connected to Pool Condenser
- Reaction heat removed by circulating BFW through U-bundle
- Corrosive carbamate at shell side
- Tube side: low pressure steam

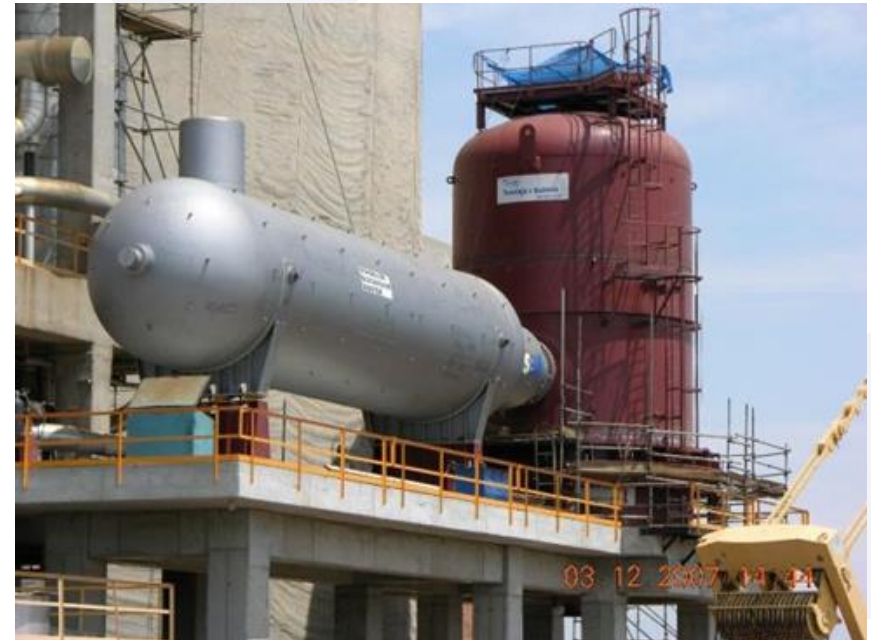
- In total 37 Pool Condenser and Pool Reactor are in operation
- Risk assessment: likelihood for FAC damages to occur
 - Based on process and mechanical design data
 - Plant capacity
 - Design flow BFW
 - Expected velocities Steam condensate at outlet
 - BFW condition program in place
 - Inspection results
 - On-stream time
- High, medium and low risk equipment identified
