HPCC Tubesheet repair after conductivity increase in the steam condensate due to the leakage

Workshop 14th Stamicarbon symposium

Cagri Ozturk 19 May 2022 Jaarbeurs, Utrecht

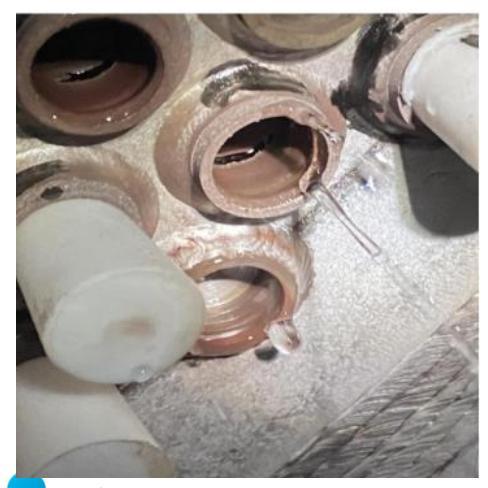
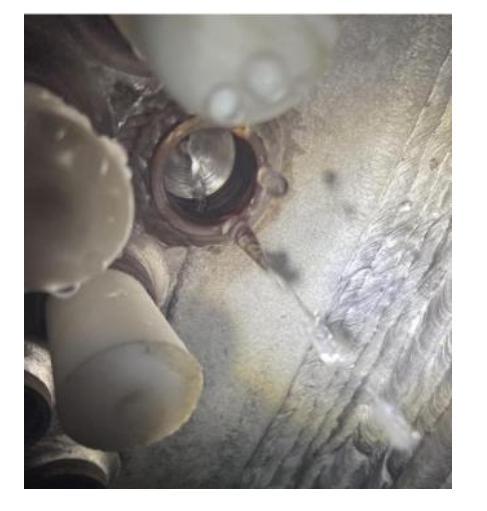
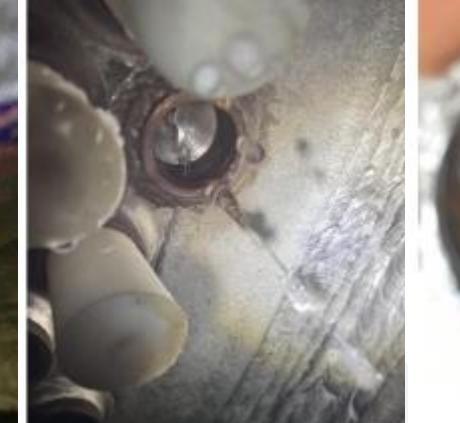
- In case of a leak, there will be increase in the conductivity of the steam condensate by disassociation of carbamate into ammonia and CO2
- Therefore, the steam conductivity is being monitored as leak detection system
- Leak can be occur at and caused by:
 - At HP section tubesheet side (caused by leaking tube to tubesheet weld, plug, weld overlay)
 - At LP section steam side (caused by the stress corrosion cracking)
- In Stamicarbon heat exchanger design concept, expansion/rolling of the tubes in the tubesheet is not allowed (leak path)
- The steam conductivity is typically monitored from the steam drum and/or blowdown of HPCC
- Stop the plant immediately in case of a suspected leakage

A leaking plug

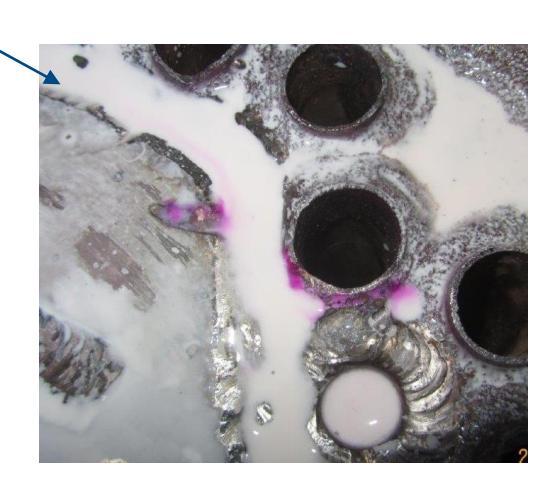
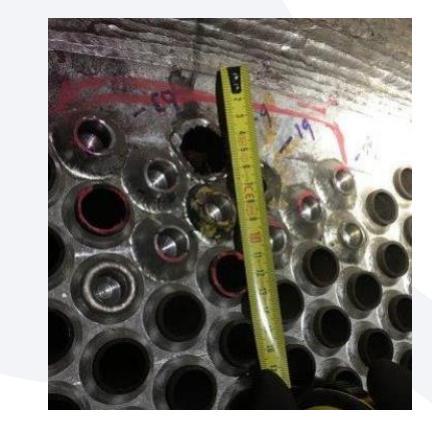
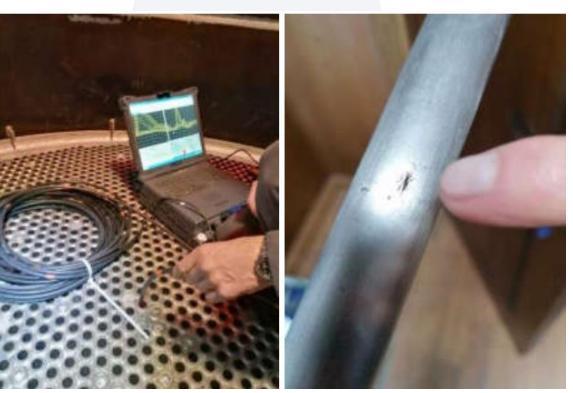
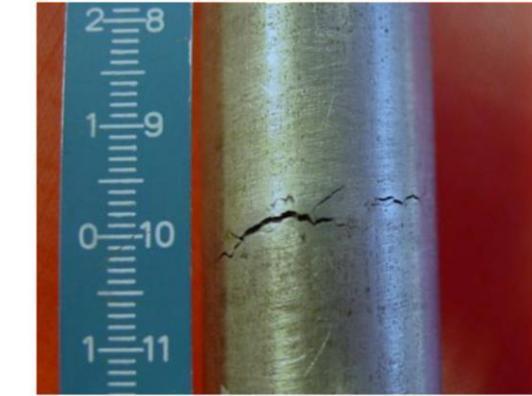
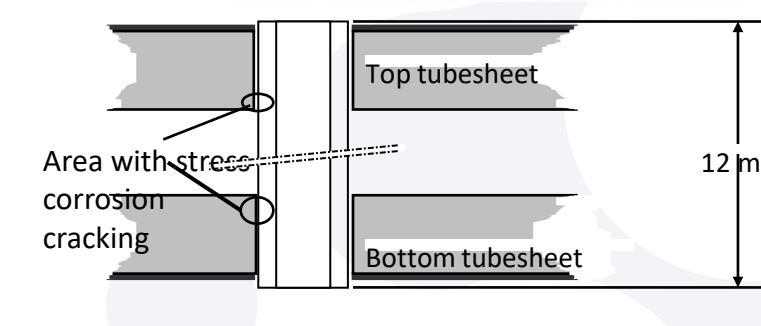
- Visual inspection of the bottom/top tubesheet and tubes
- Eddy Current examination to detect missing carbon steel in the tubesheet
- Eddy Current examination to determine the presence of Stress corrosion cracking in the HEX tubes
- Hydrostatic test by water to identify leaking tubes (filling the shell with condensate water)
- Leak test by air/nitrogen
- Ammonia leak test
- Helium leak test is not preferred

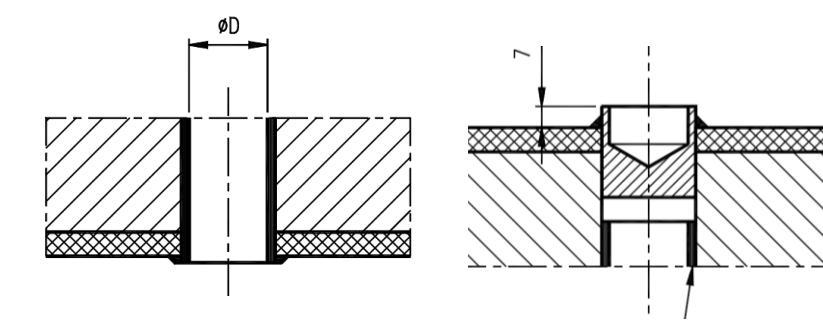
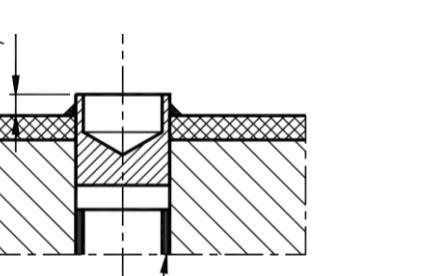
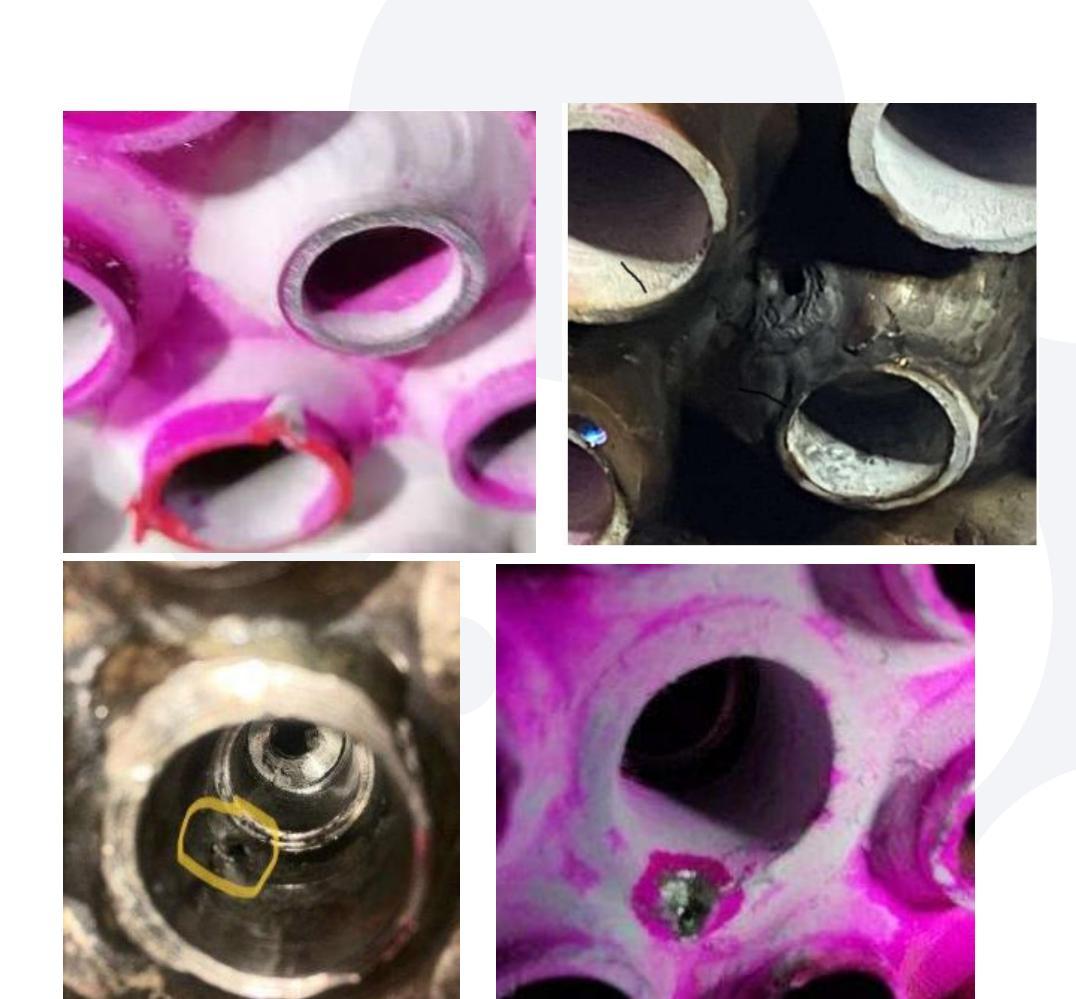
PLUG ON A TUBE

Every new plug that being installed in the HPCC is increasing the risk of another potential leakage

- During a such tubesheet repair, plugging of some tubes will be needed. (plugging the tubes next to the cavity area, the tube ends at the opposite tubesheet)
- Besides, the tubes with the Stress corrosion cracking indication, depending on the measured crack depth by ECT, can be needed to get plugged.
- In all cases plugging a tube introduces a potential for leakages. It is important to . make proper preparations for optimal plugging executing to achieve safe operations.
- Potential risks such as use of inferior plug material, introduce of welding heat, difficulties of welding, poor workmanship, wrong plug design, present defects originated from the fabrication..etc
- Proper plugging and welding procedures also a proper weld executing is of importance
- Proper NDE/visual checks in accordance with the procedure
