STAMICARBON'S INSPECTION SERVICES

Part of the ADVANCE series

NX STAMIUREA

EXTEND THE SERVICE LIFE OF YOUR PLANT

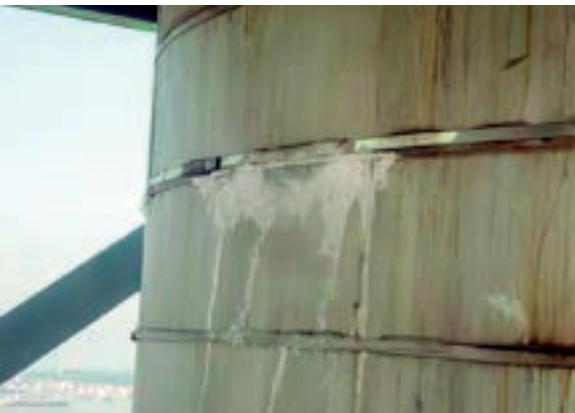
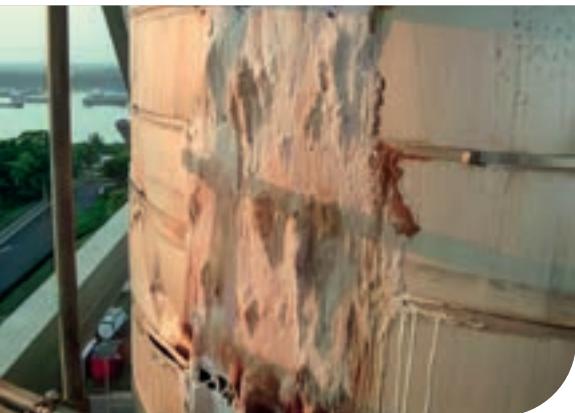
08:30 - November 5, 2015

NEAR MISS CATASTROPHIC FAILURE OF UREA REACTOR

During the daily round, the plant operator observed crystallized product contamination on the outside of the urea reactor. The plant was stopped within one day to open up the reactor for inspection. A leak was observed in a liner weld and upon removal of the liner plate, severe corrosion of the pressure shell was observed. The plant was stopped just in time to prevent a catastrophic failure. The corrosion damage was repaired and the reactor was put into service again safely.

The cause

The leak was caused by a defect in a liner weld, which was missed during routine inspections. Unfortunately, the leak detection system was out of order and the unavailability of the leak detection system worsened the situation to near-catastrophic.

Lessons learned

Small invisible defects are potential threats to the structural integrity of critical HP urea equipment. So in addition to scrupulous inspections by experienced inspectors, the final line of defense (leak detection system) should also be checked and maintained properly.

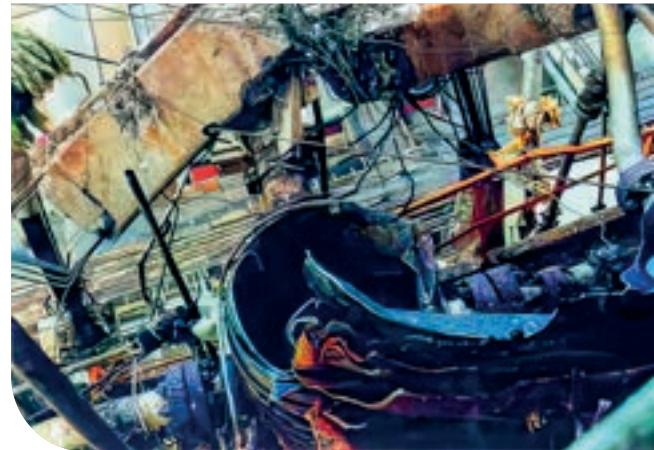
During normal operations, suddenly the high-pressure scrubber ruptured and caused damage to the structure. Fortunately, nobody was injured.

A small leak in a patch plate weld on the liner was not noticed and created severe corrosion in the c-steel pressure shell resulting in the rupture of the vessel. The root cause of this mishap is the combination of:

Ruptured HP Scrubber

1. The patch plate was not inspected on regular basis
2. The leak detection system was not available

Inspection of critical high-pressure urea equipment needs to be done on a regular basis. Furthermore a good functioning and maintained leak detection system is of paramount importance as last line of defense to avoid catastrophic failure.
